NUMBER: 09-005-17 REV. B

DATE: August 22, 2017

2.0L Coolant Hose O-Ring Replacement

2017 (GA) Alfa Romeo Giulia

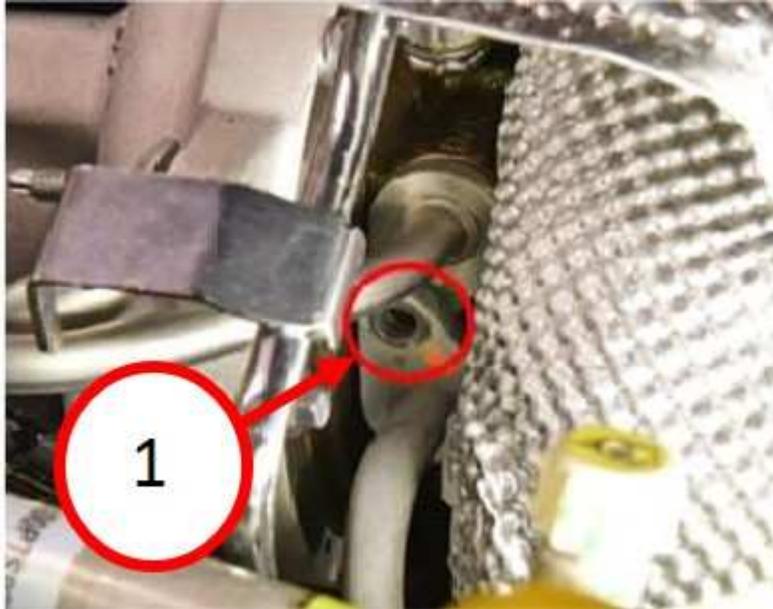
Fig. 1
Turbocharger Coolant Hose

The customer may experience a small coolant leak from the O-ring seal of the turbocharger coolant return hose.

1 - Turbocharger Coolant Hose (Shown with bolt removed)

1. **Remove the coolant inlet tube (lower position) to allow the outlet tube (upper position) to be removed from the turbo. A black O-ring on the Outlet tube needs to be replaced with an orange O-ring (Fig. 1) .** Refer to the detailed service procedures available in DealerCONNECT> TechCONNECT under: 09 - Engine, 2.0L/Turbocharger System/Lines, Tubes and Hoses, Turbocharger, Oil and Coolant/Removal.

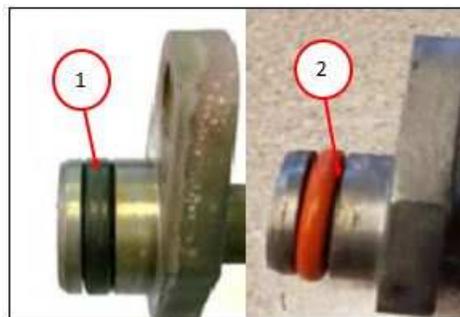
Fig. 2
Turbocharger Coolant Hose O-rings

1 - Bad O-ring (Black)
2 - Good O-ring (Orange)

2. Replace the O-ring attached to the end of the coolant return hose (Fig. 2) with the new one listed in Parts Required.
