013.21

VARIOUS MODELS - LIGHTING DEVICES

Condensation forming or Water infiltration – Service Solution

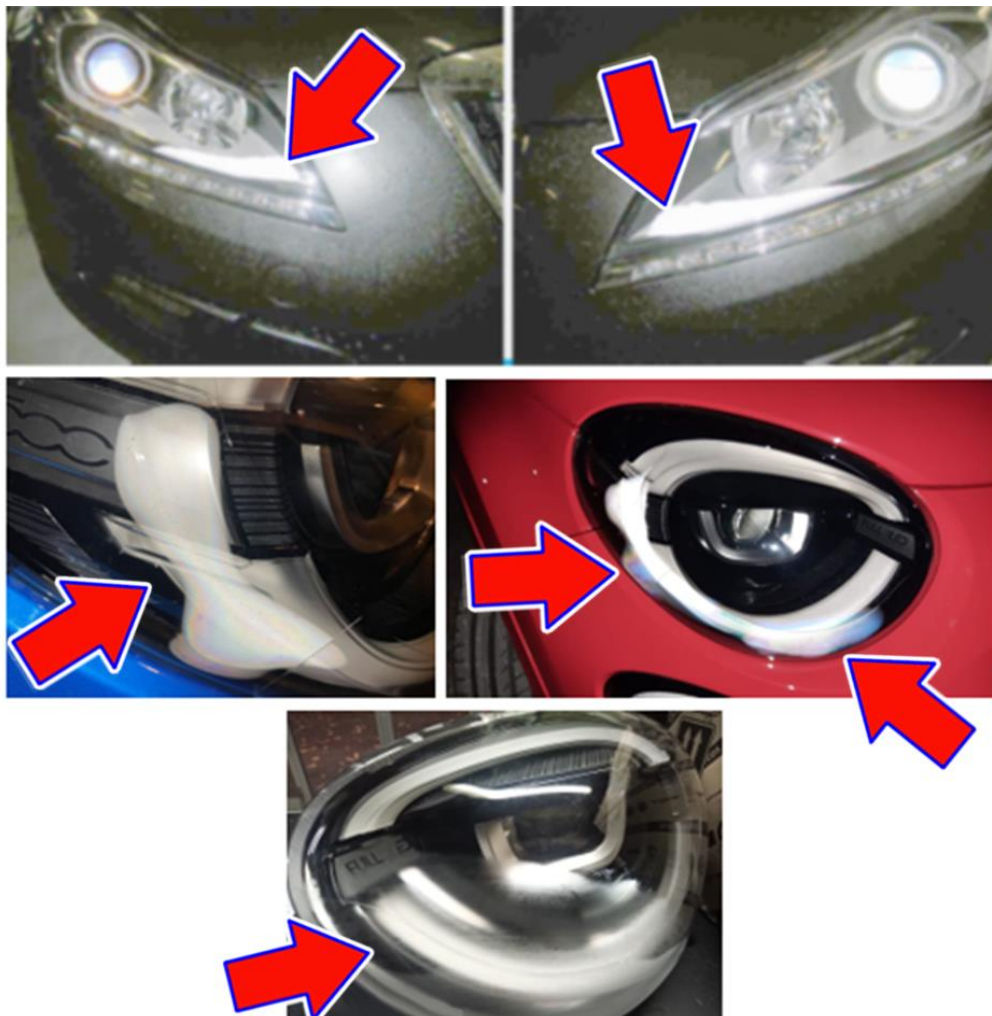
Fig. 1 condensation forming

a) In some conditions of use, misting may appear inside the lighting devices. See the examples in Fig. 1.

Once the claimed fault is confirmed, do not replace any components, but inform the customer that this is a natural physical phenomenon that occurs in particular conditions (heavy rain, storms, washing the car, temperature changes) when the outside air is very humid and there is a temperature difference between the inside and the outside of the headlight.

The lighting devices have vents to ensure the ventilation needed to disperse any condensation that forms on the cooler parts of the devices.

A certain time is therefore required to eliminate the condensation through air circulation in the vents, which could depend on the atmospheric humidity and temperature.

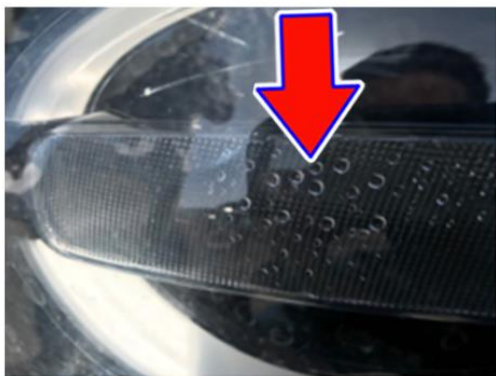
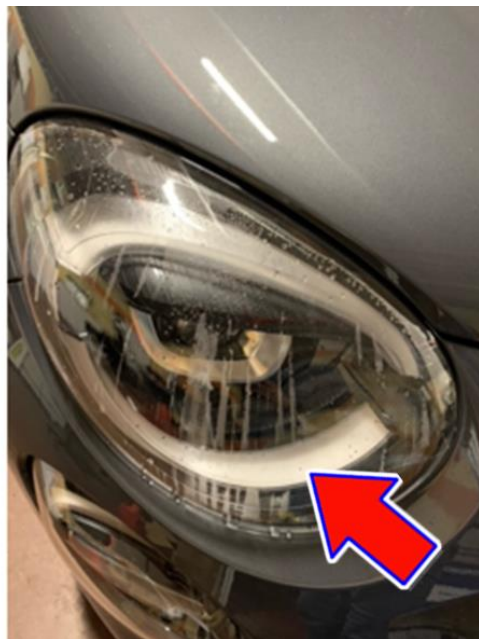
Fig. 2 water infiltration

b) Water infiltration in the lighting devices, with water drops/trickles and/or water build-up inside the component. See the examples in Fig. 2.

If there is water infiltration in the lighting devices, replace the devices affected.

The repairer must take photographs to document the water in the lighting device(s).

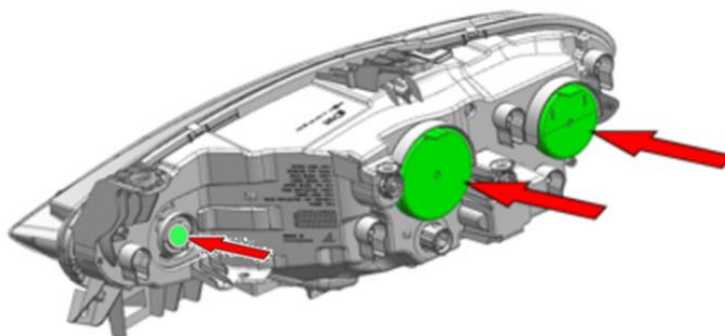
For headlights with lamps, check the caps indicated by the arrows in Fig. 3. These caps could have been fixed incorrectly when replacing the light bulb or could be damaged. If the caps are faulty because of the customer's actions, the repairs cannot be carried out under warranty.
