Fuel Trim and Misfire Analysis

A “No Excuse” Approach

1997 Buick Park Av

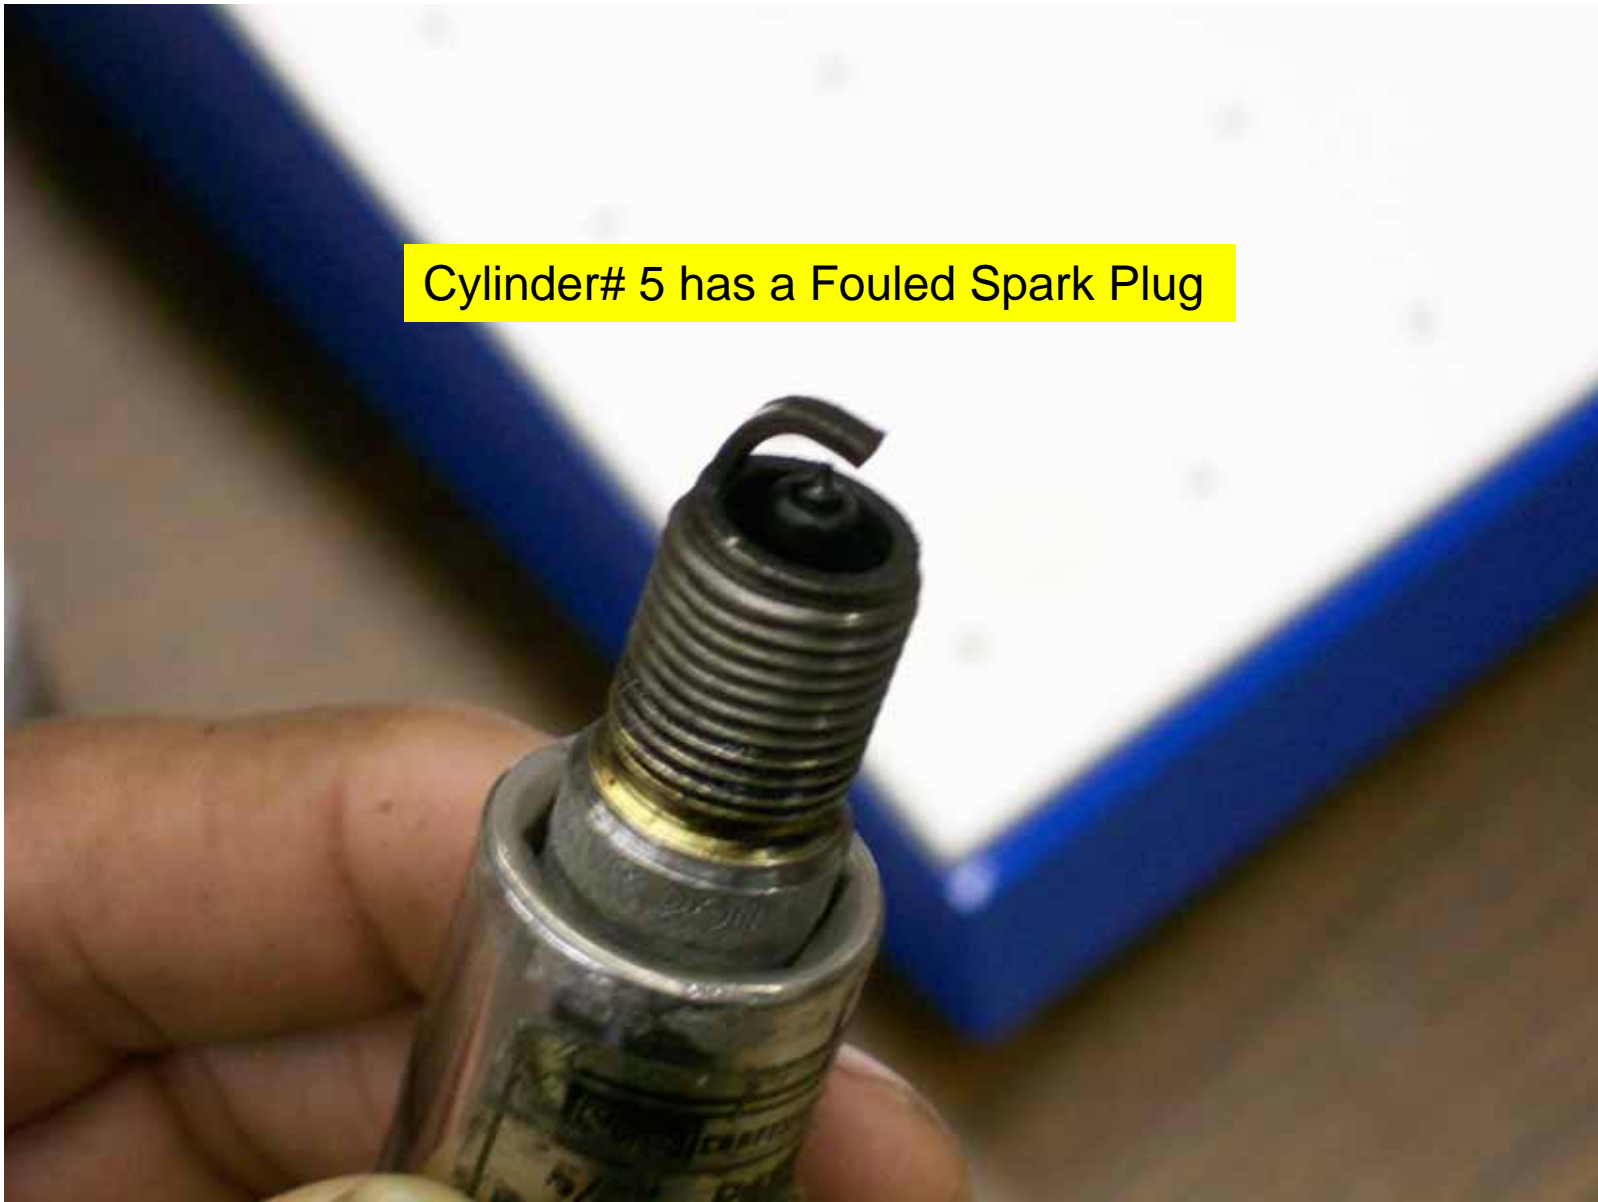
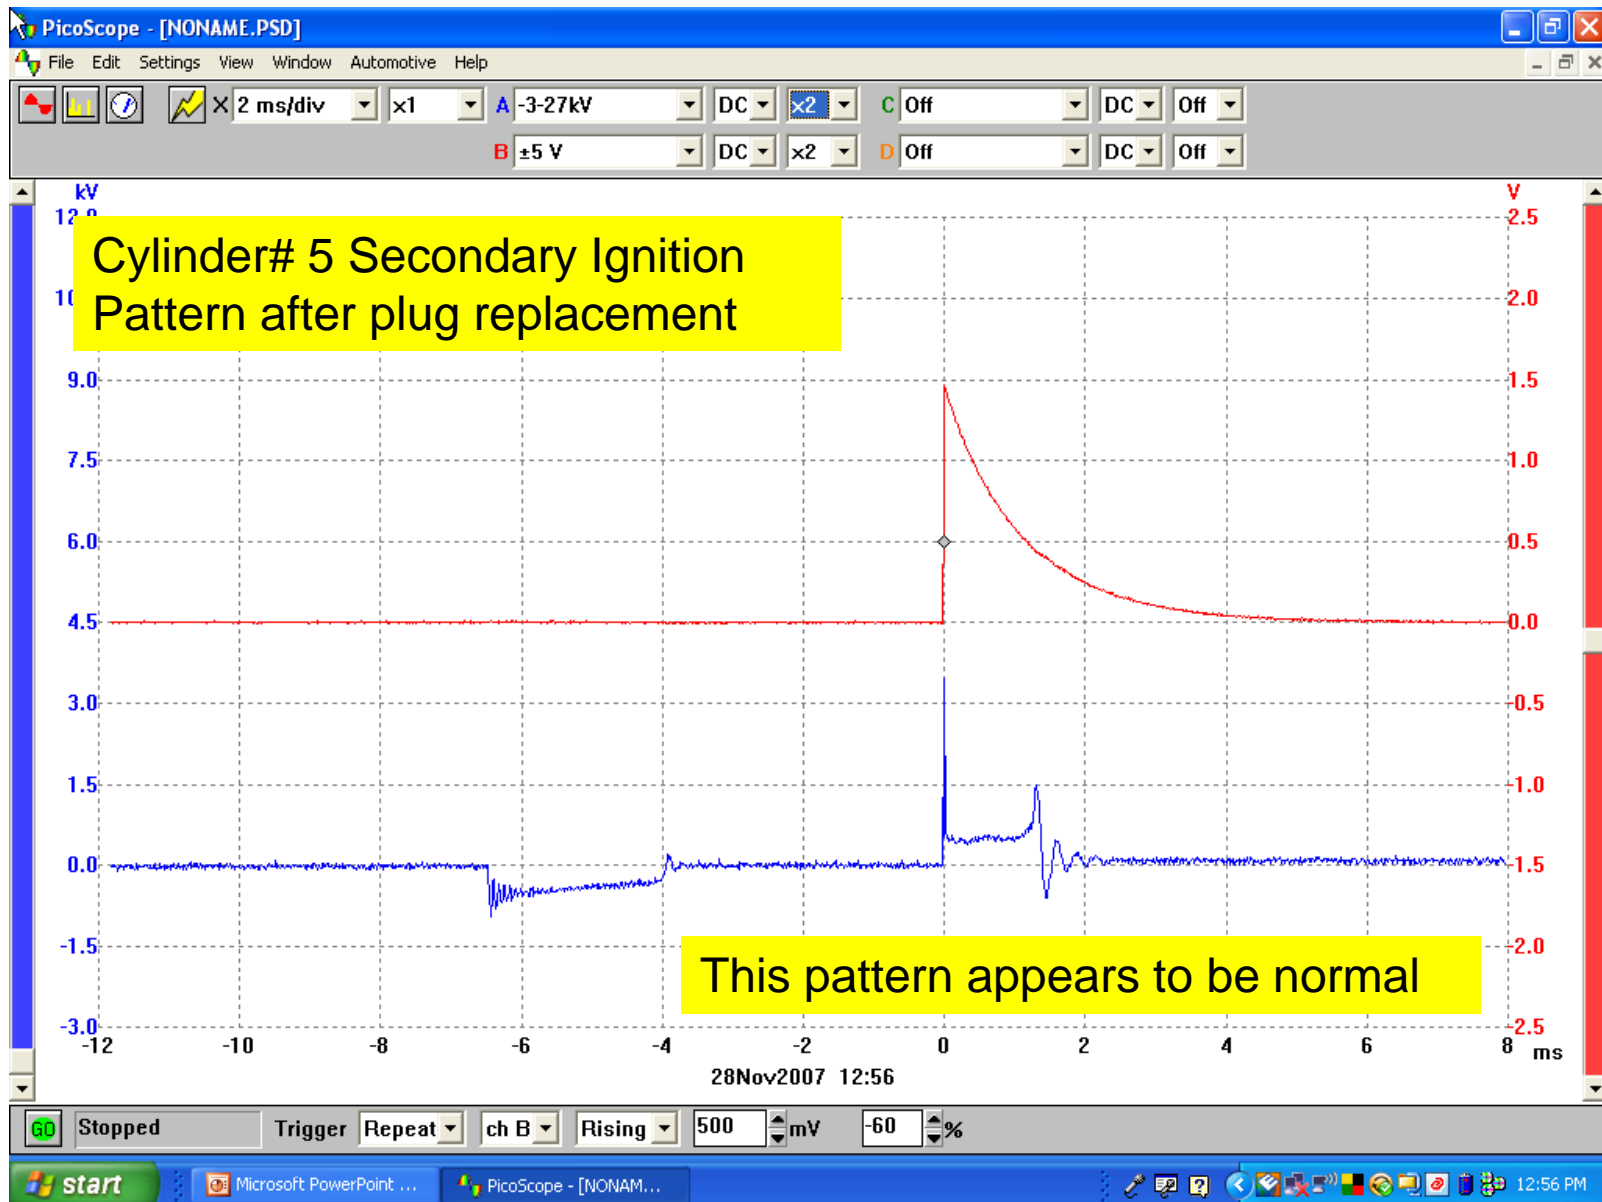
Cylinder# 5 has a Fouled Spark Plug

- The ignition wire was checked and passes its test
- A visual of the spark plug indicated it to be at a failure status

- Misfire activity on cylinder #1 and #5 has been corrected
- Cylinder #3 alone now shows consistent misfire activity on the Tech 2 scantool
- Time to review fuel trim and vacuum readings again

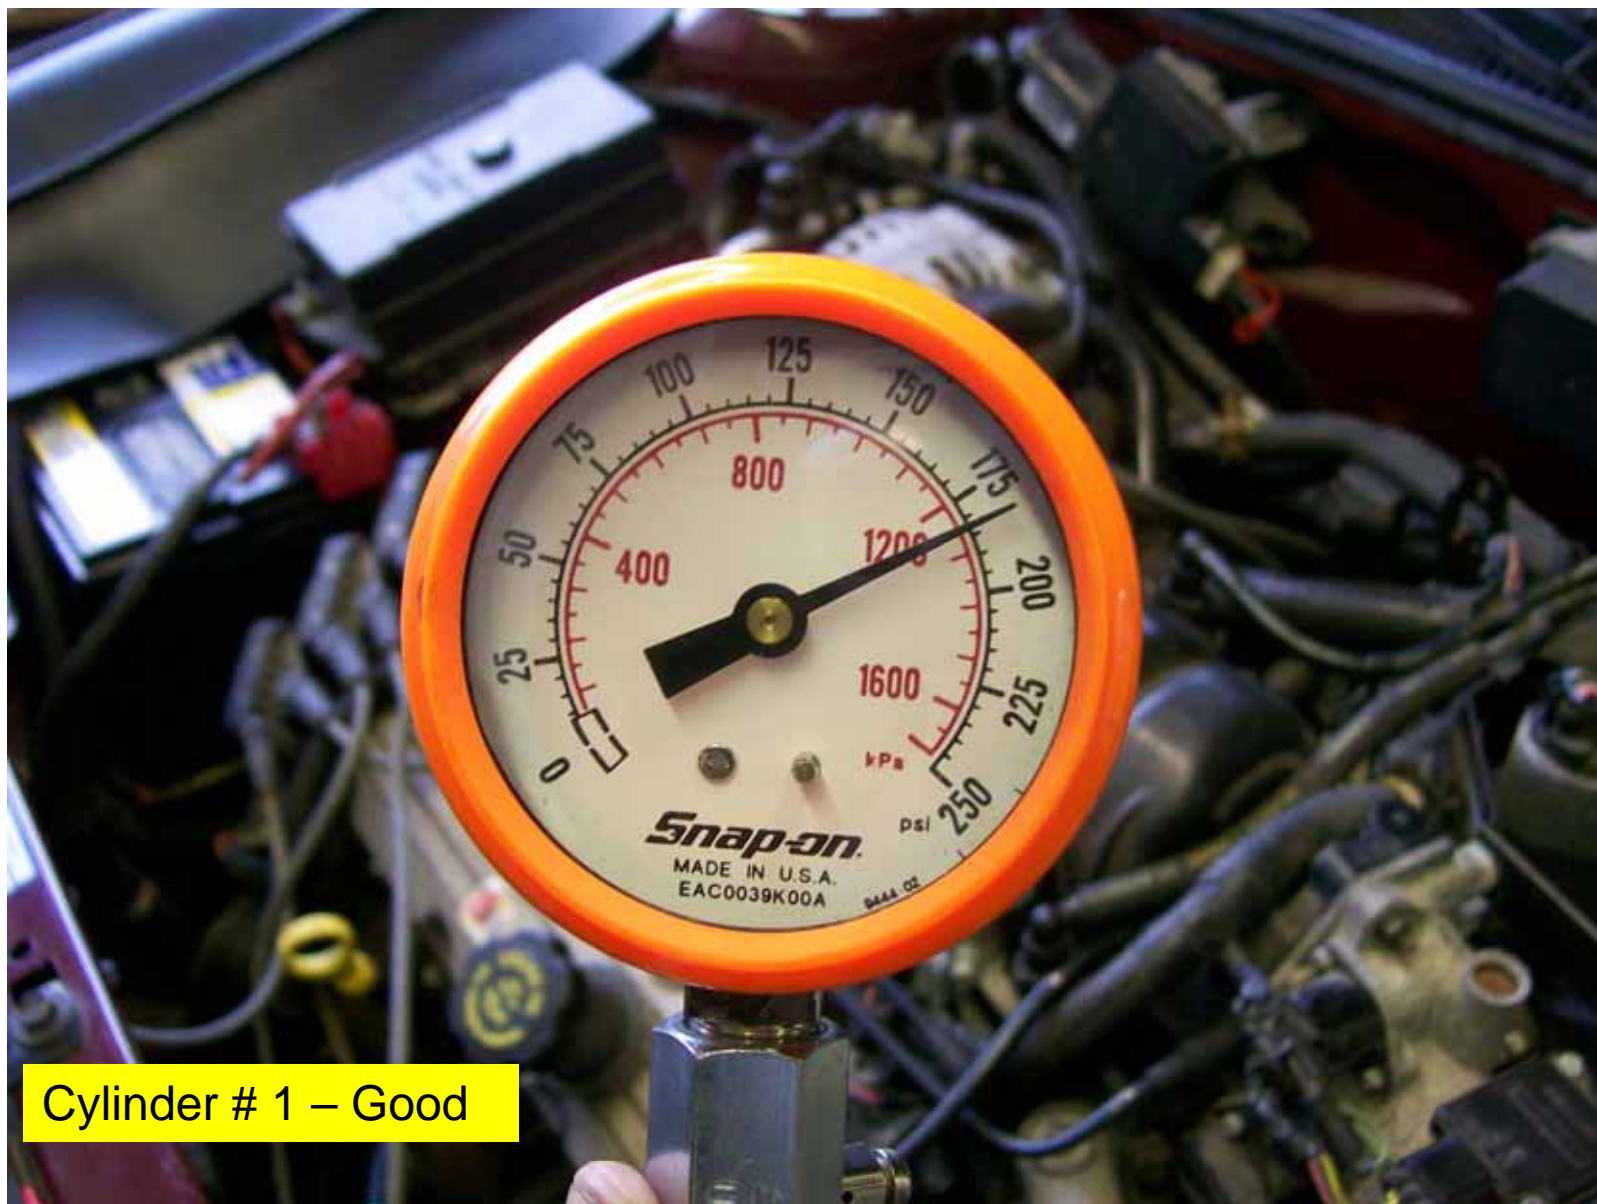
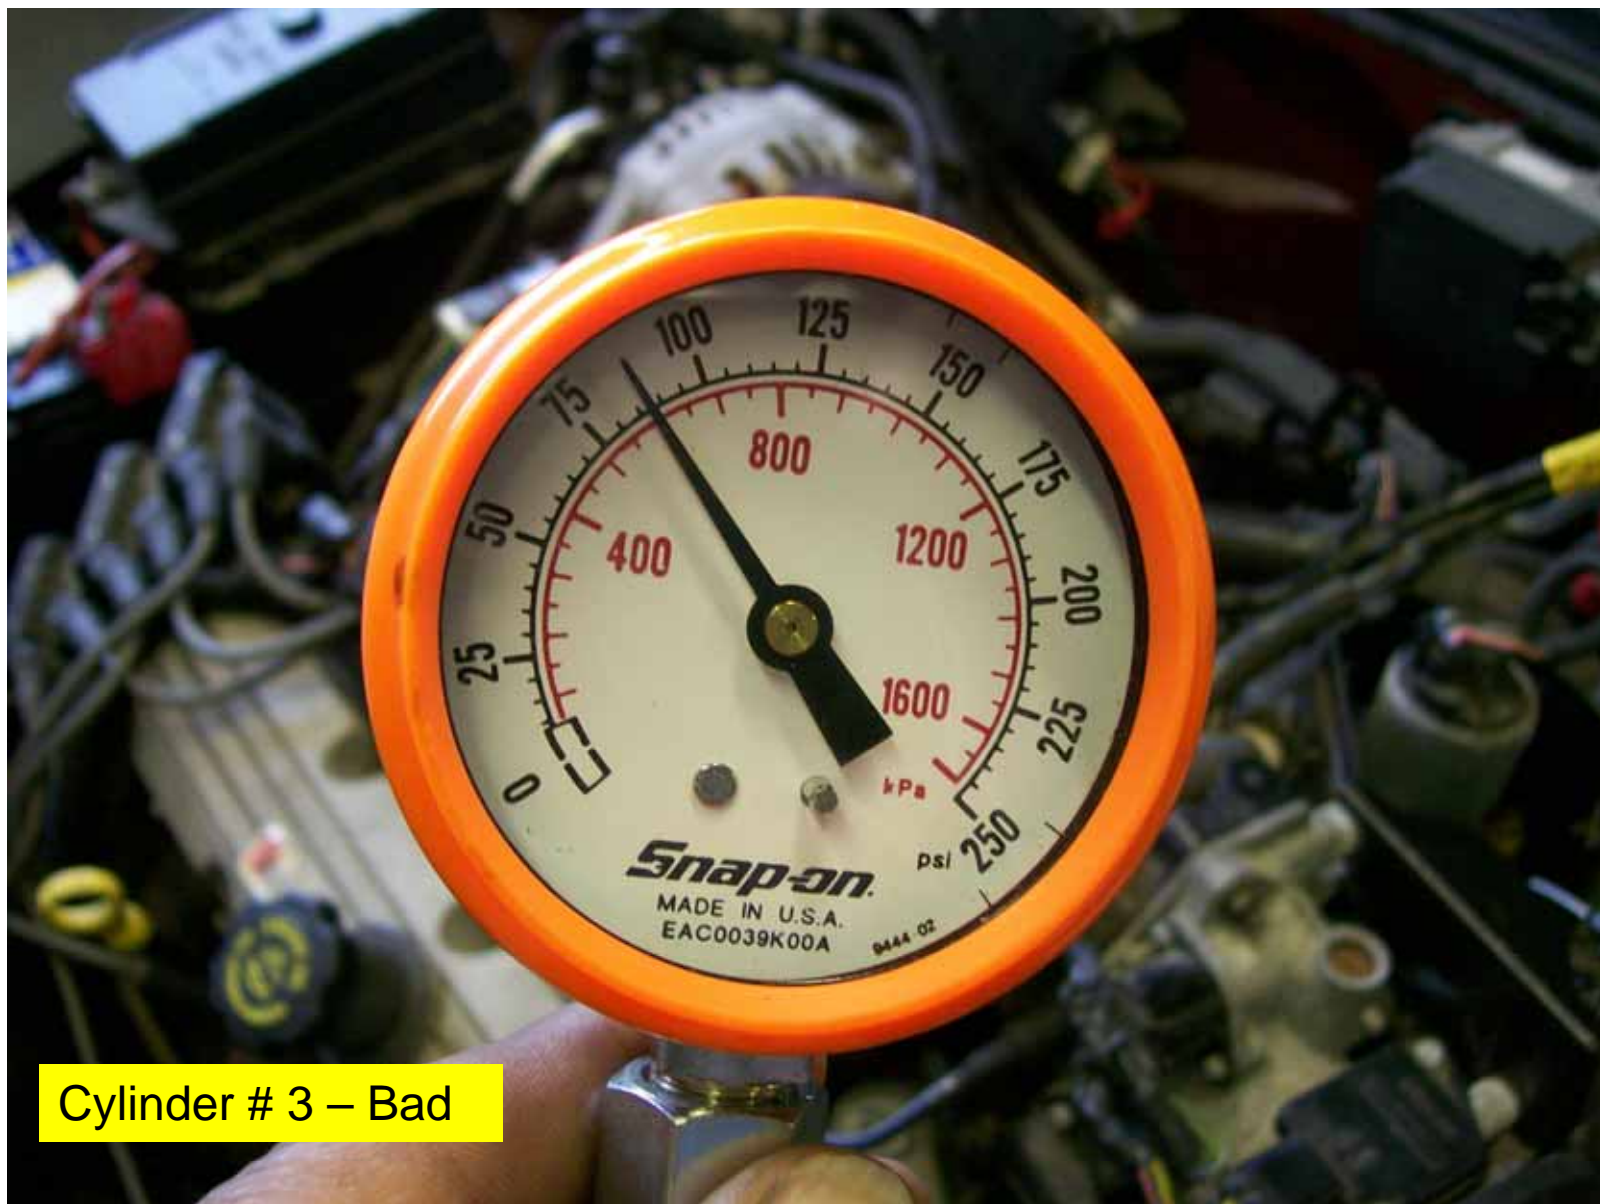
Cylinder # 3 – Bad

- If you get this activity, you should run a compression test on that cylinder right away
- The crankcase vacuum should also be checked as well as engine vacuum

- It has been confirmed that there is a mechanical issue with cylinder#3

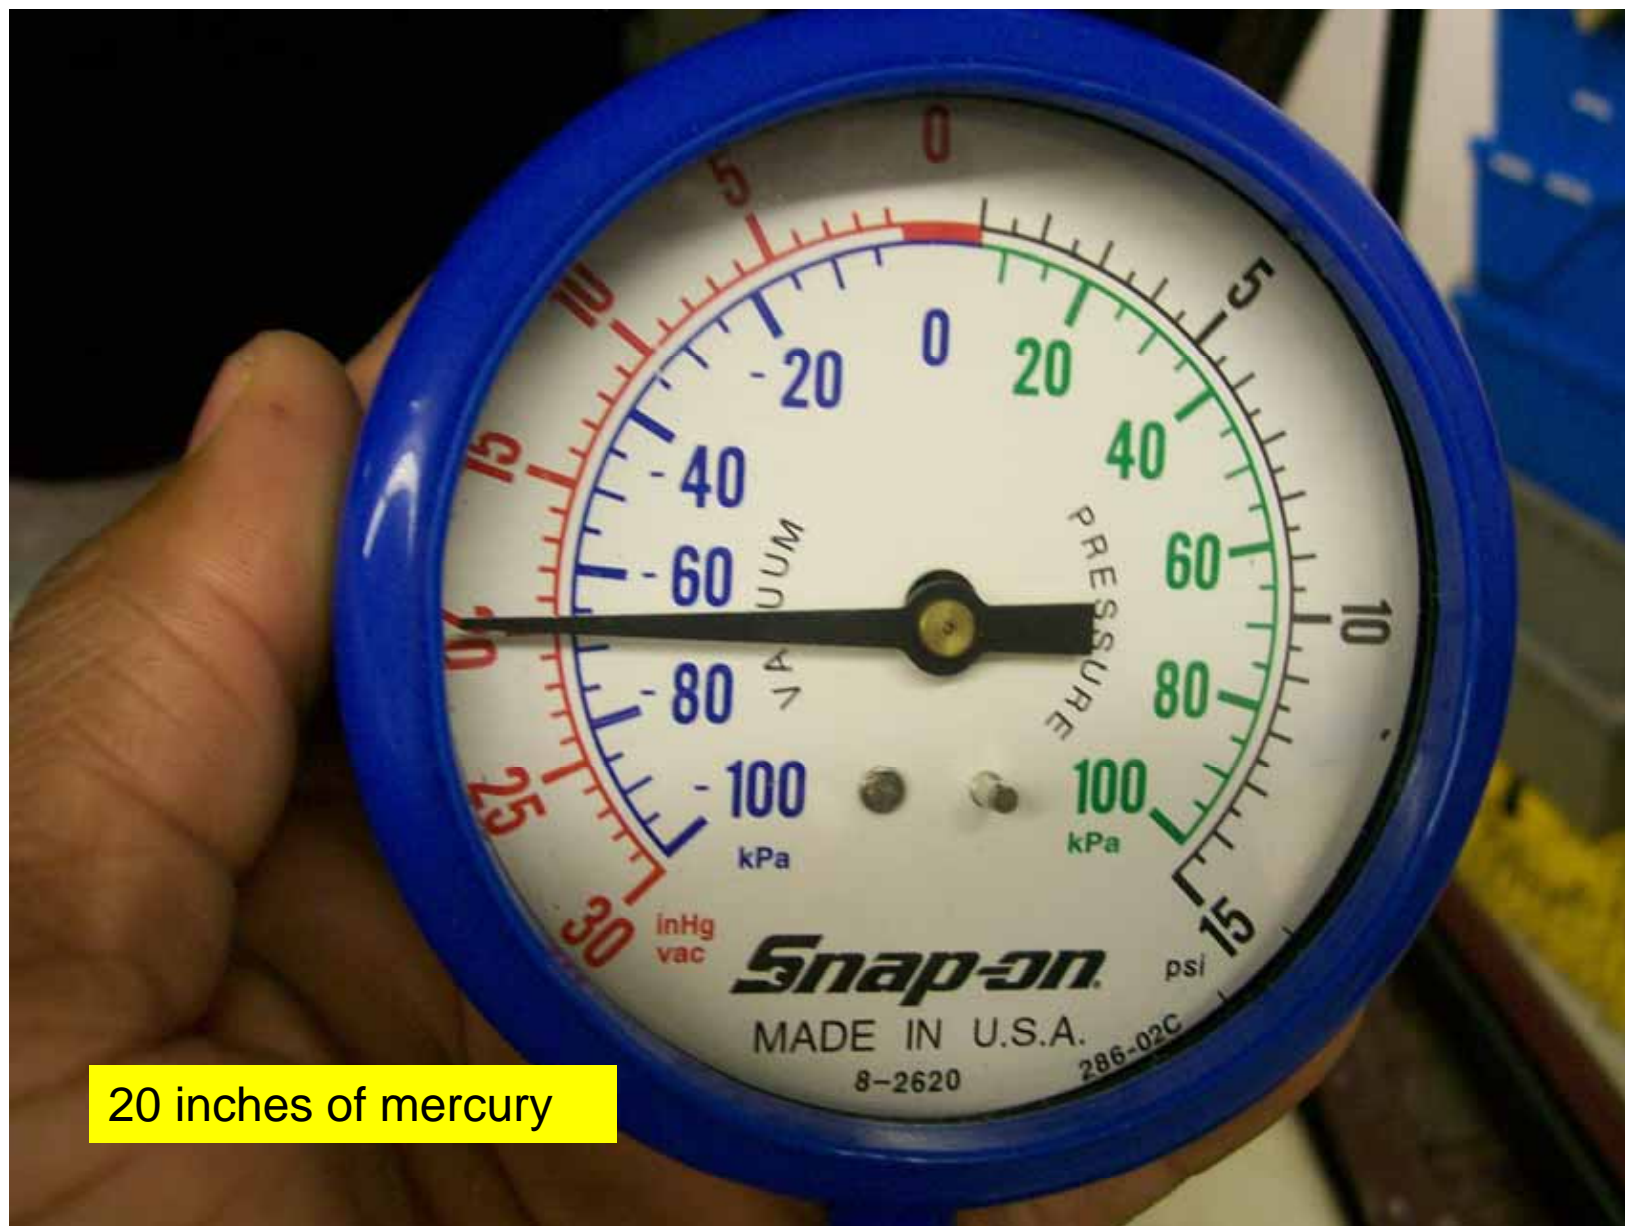
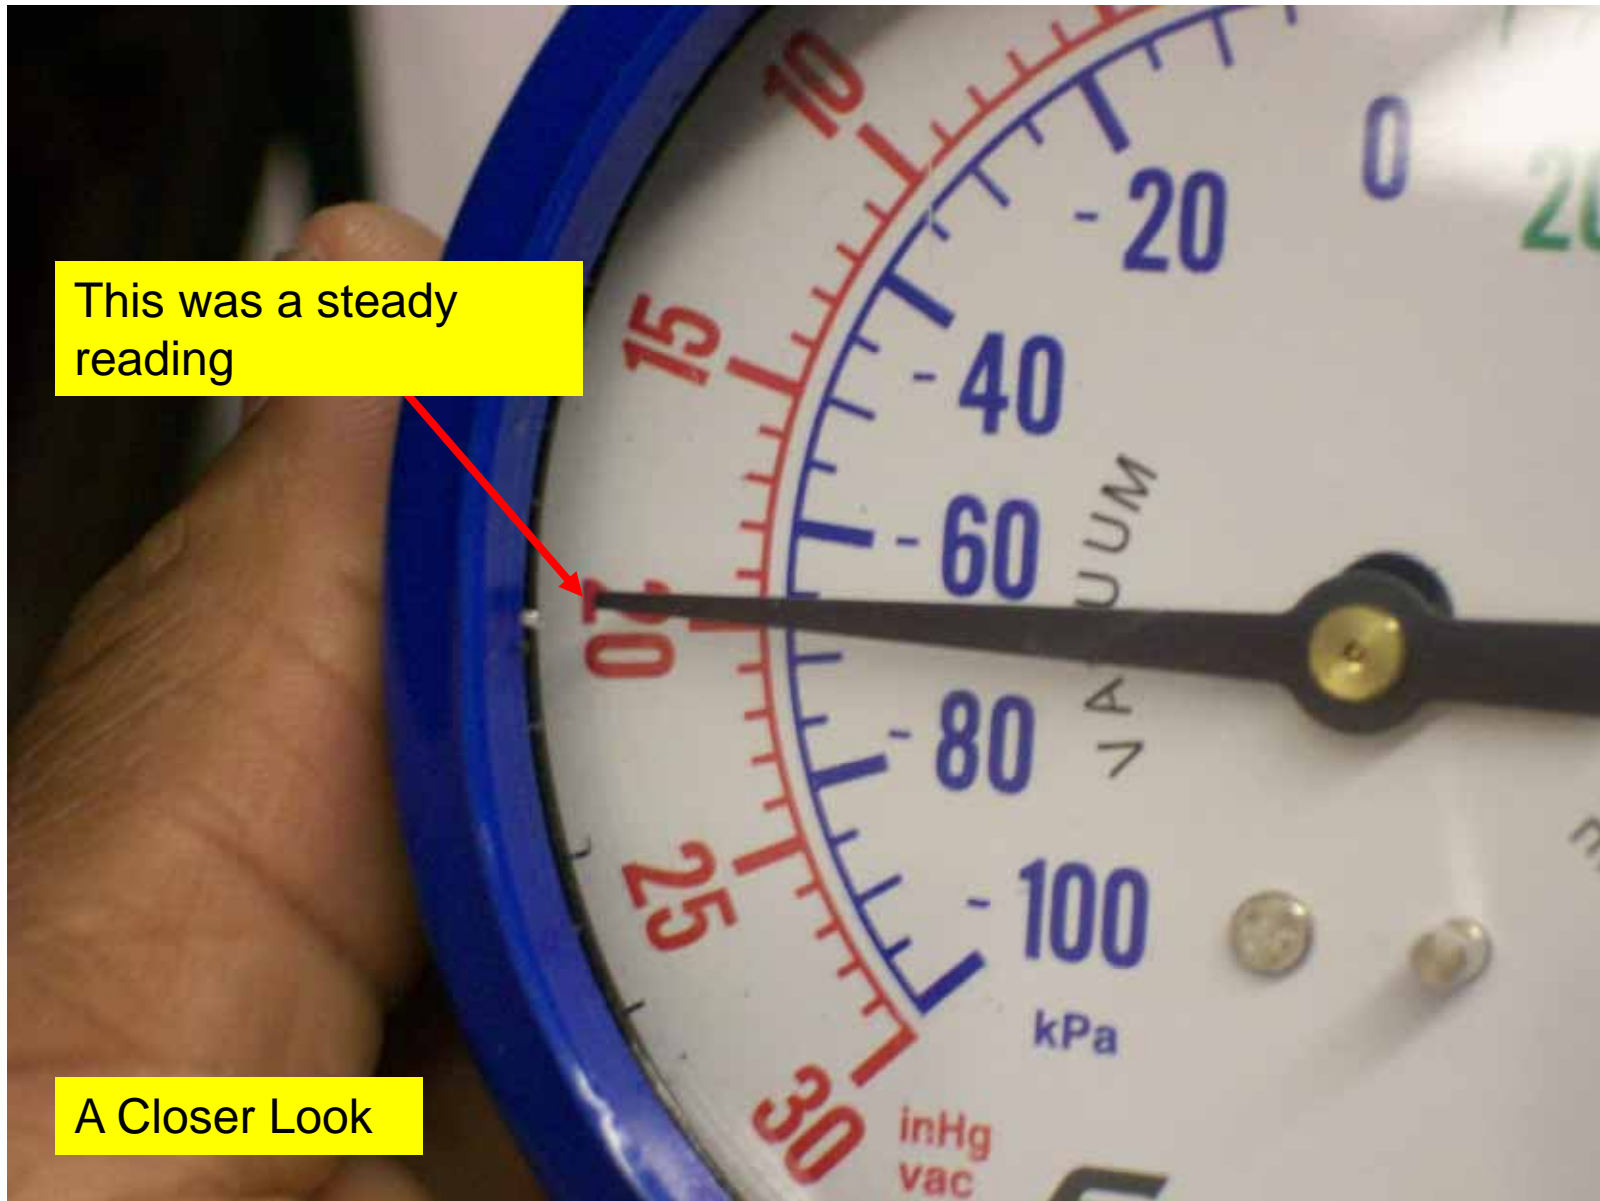
20 inches of mercury

This was a steady reading

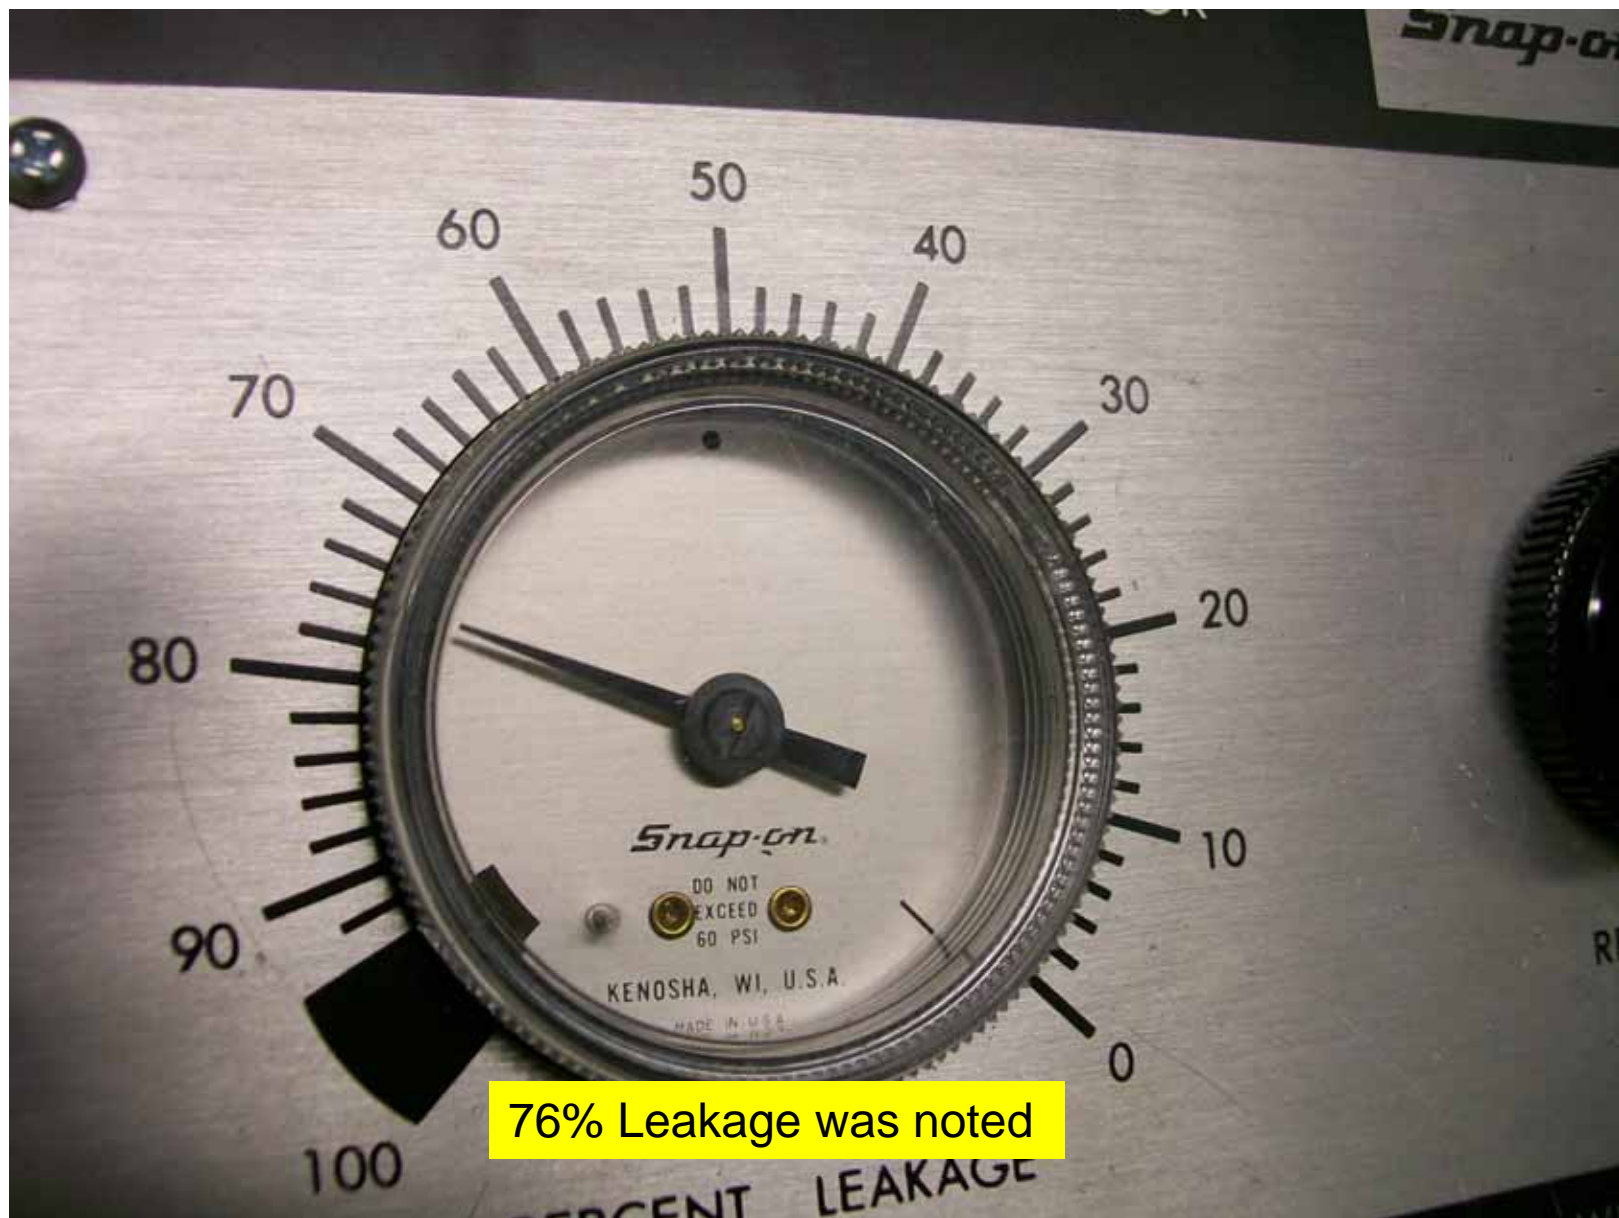
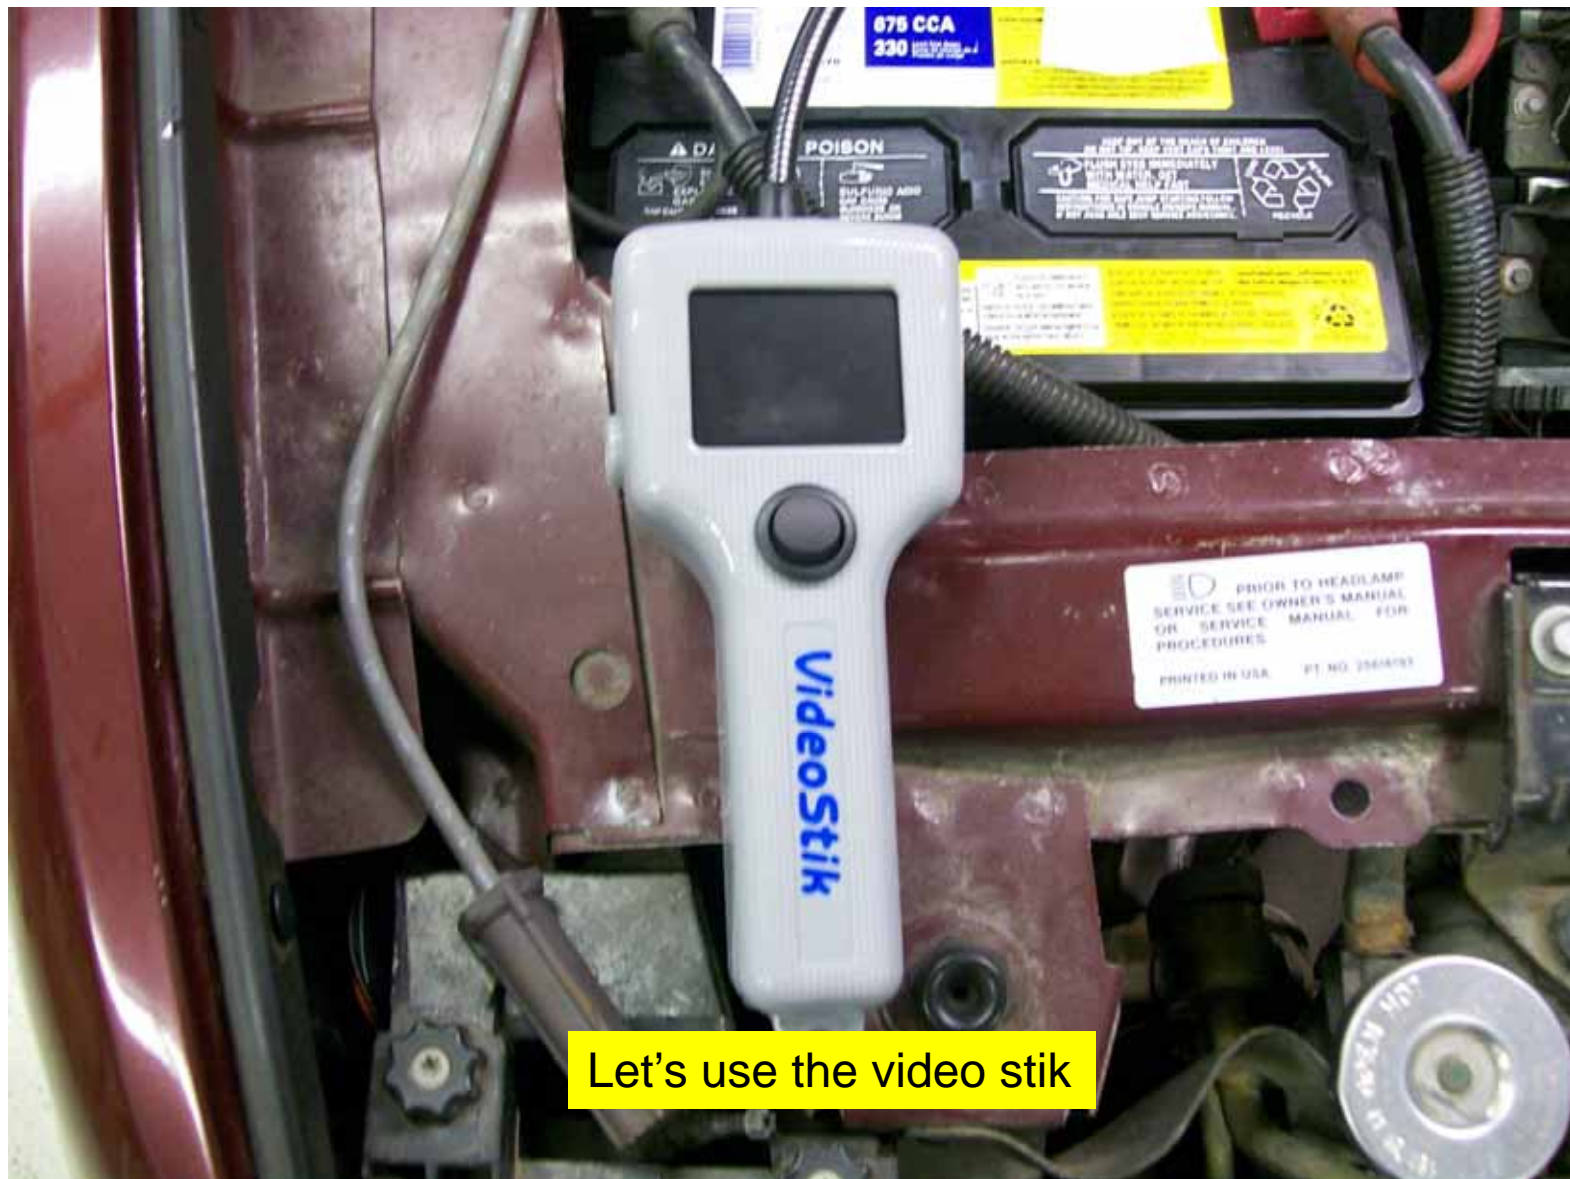
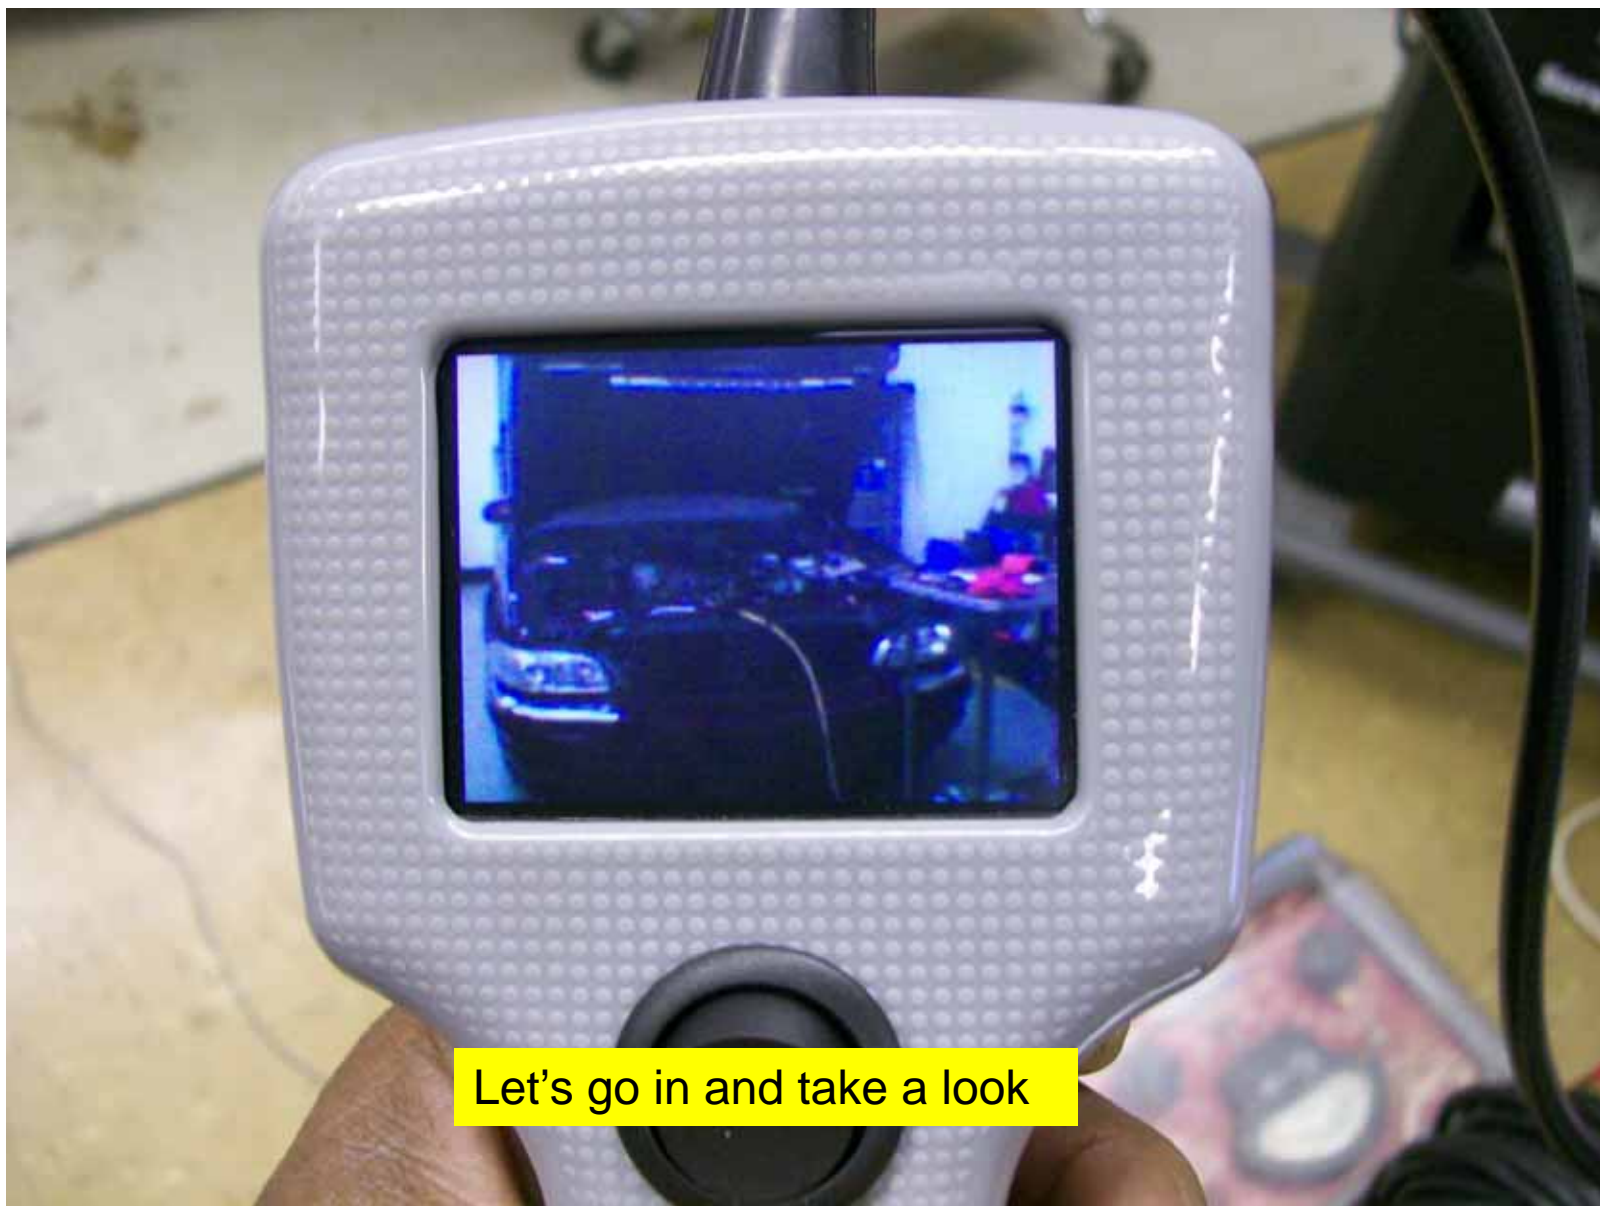
- A visual inspection of the cylinder revealed that the top of the cylinder piston head was cracked, thereby leading to a slight loss in compression as witnessed by the pressure waveform.

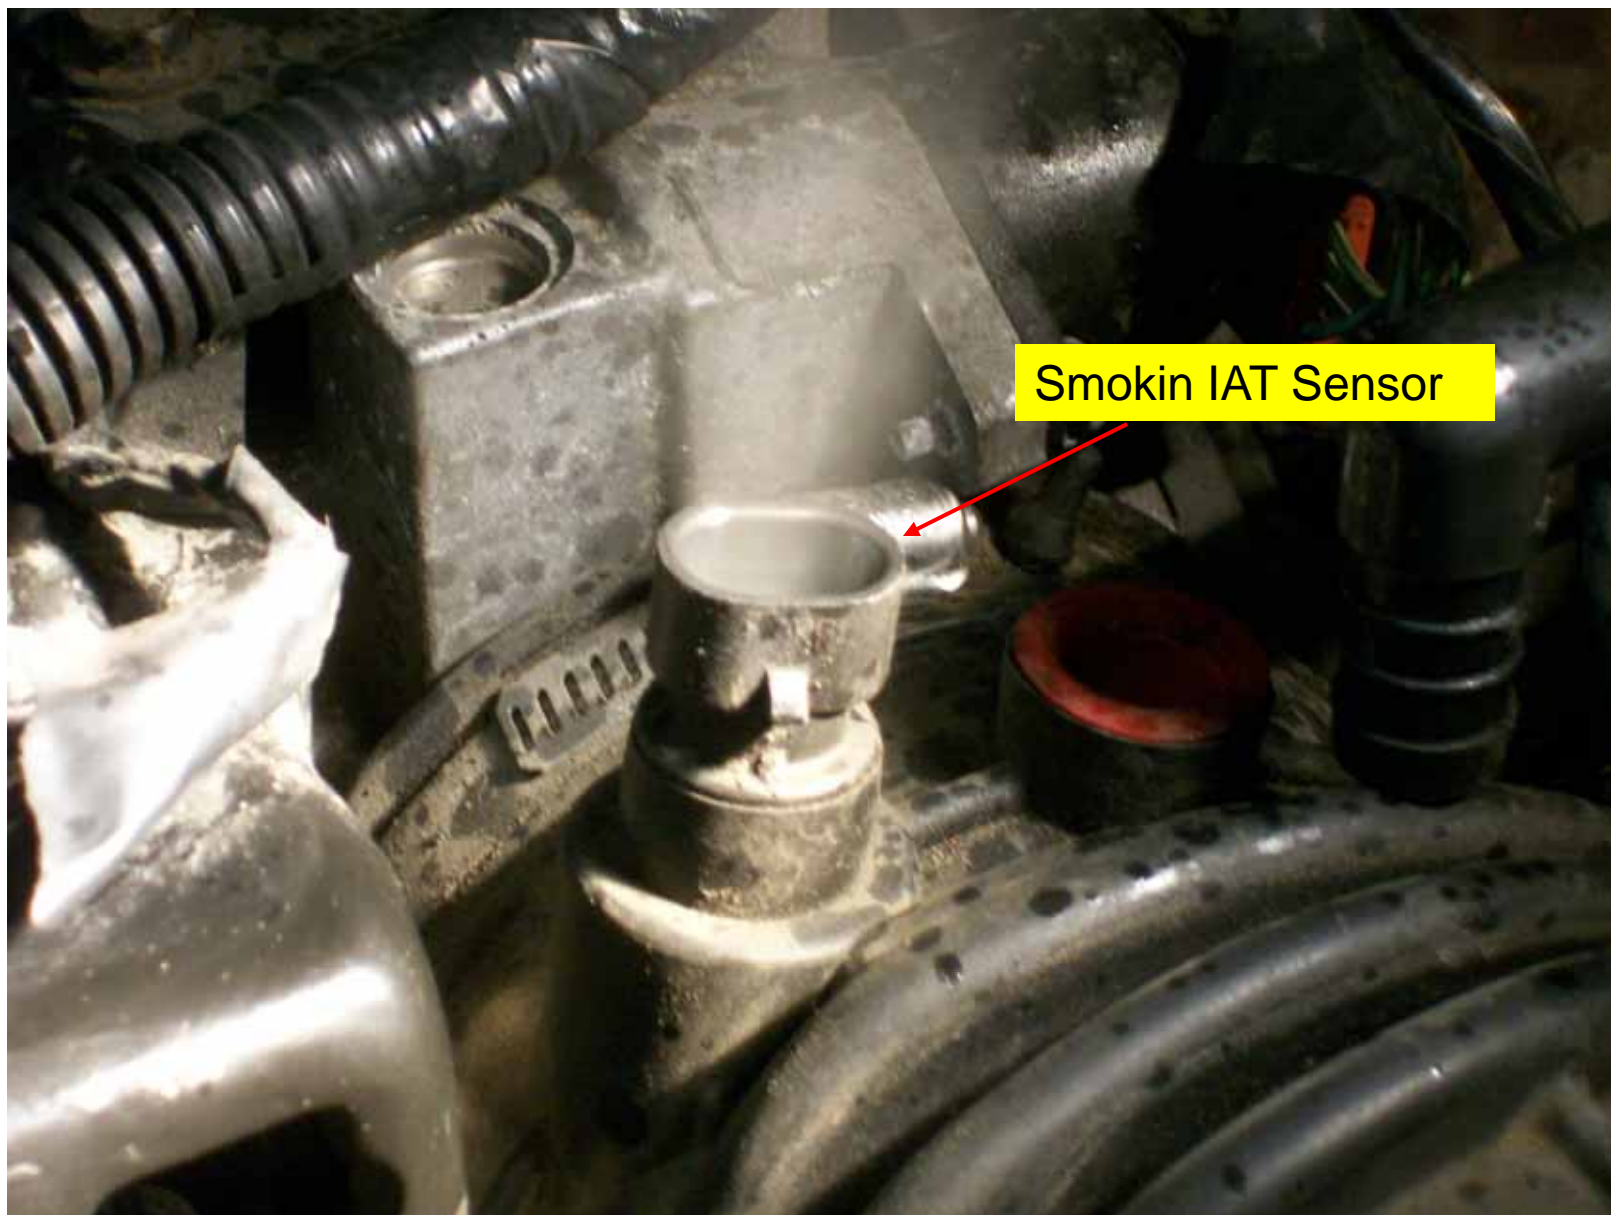
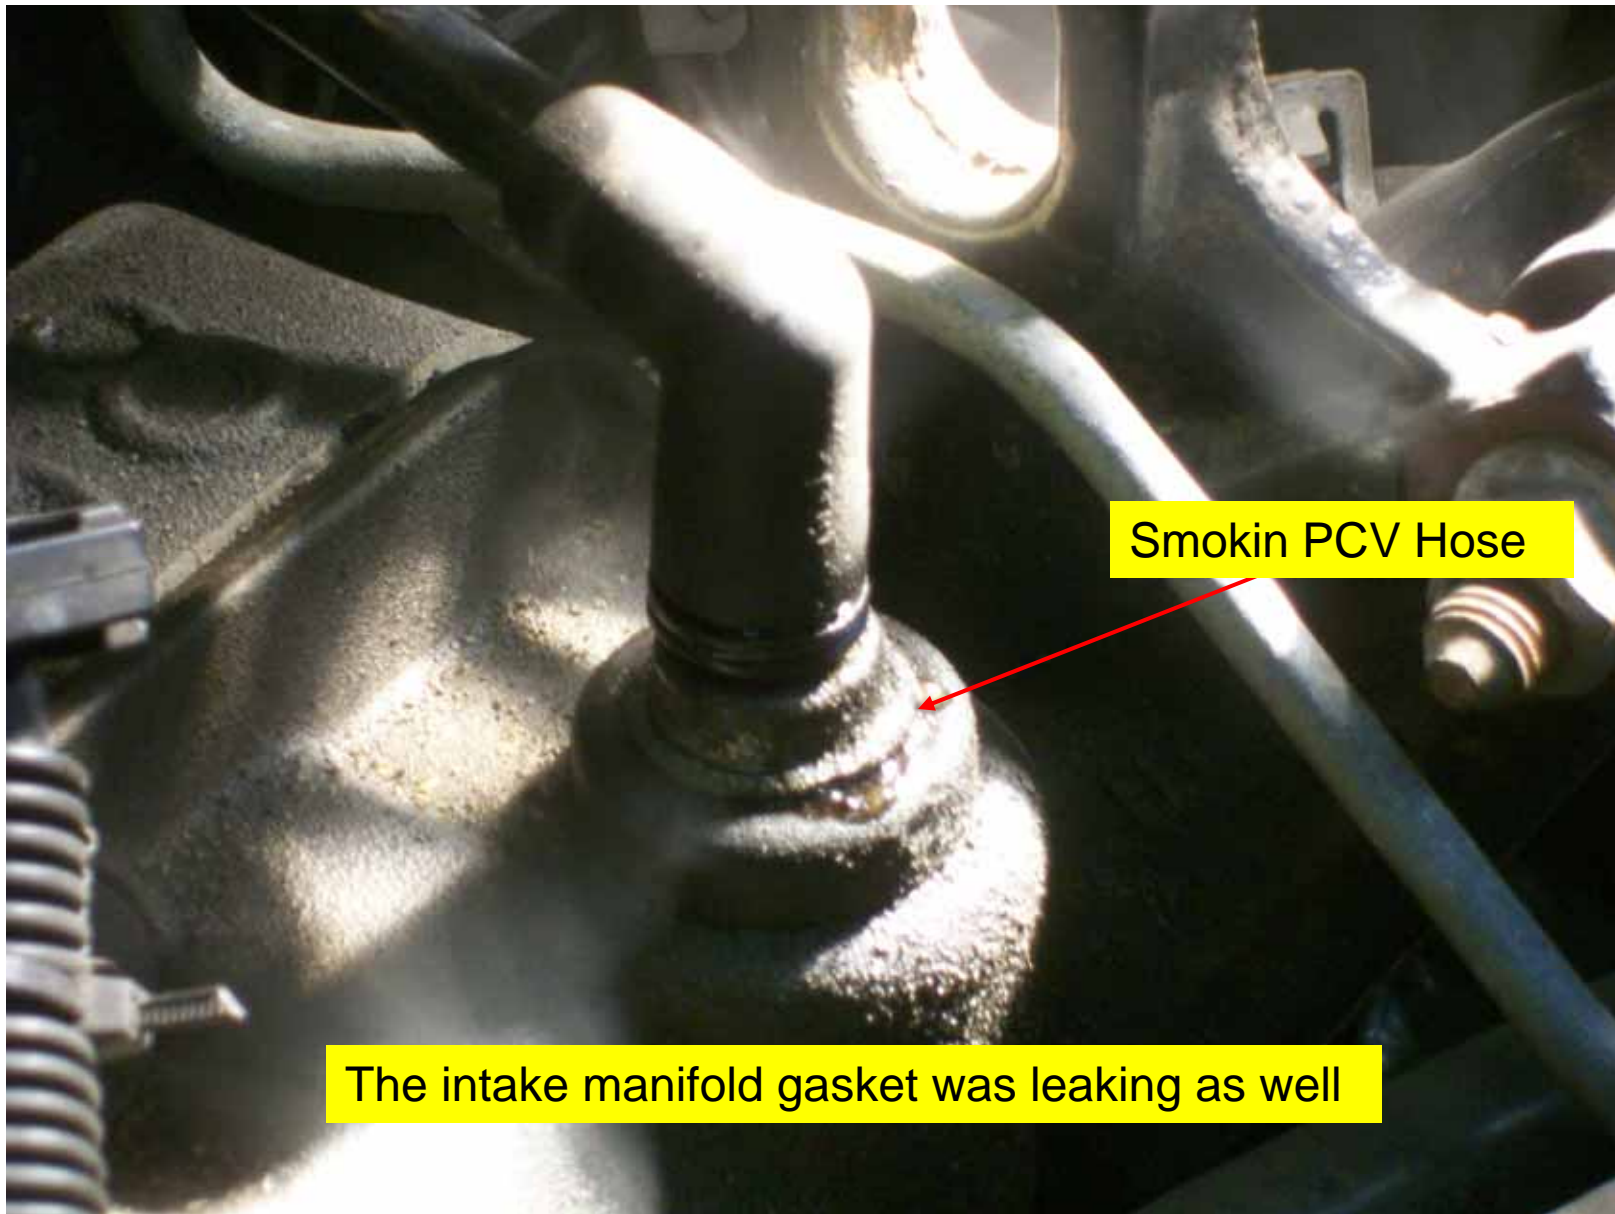
Smokin PCV Hose

The intake manifold gasket was leaking as well

- The IAT sensor and PCV valve hose assembly were replaced
- The intake manifold gasket was replaced as well
- The vehicle is now operating as designed
