Fuel Trim and Misfire Analysis

A “No Excuse” Approach

1997 Buick Park Av

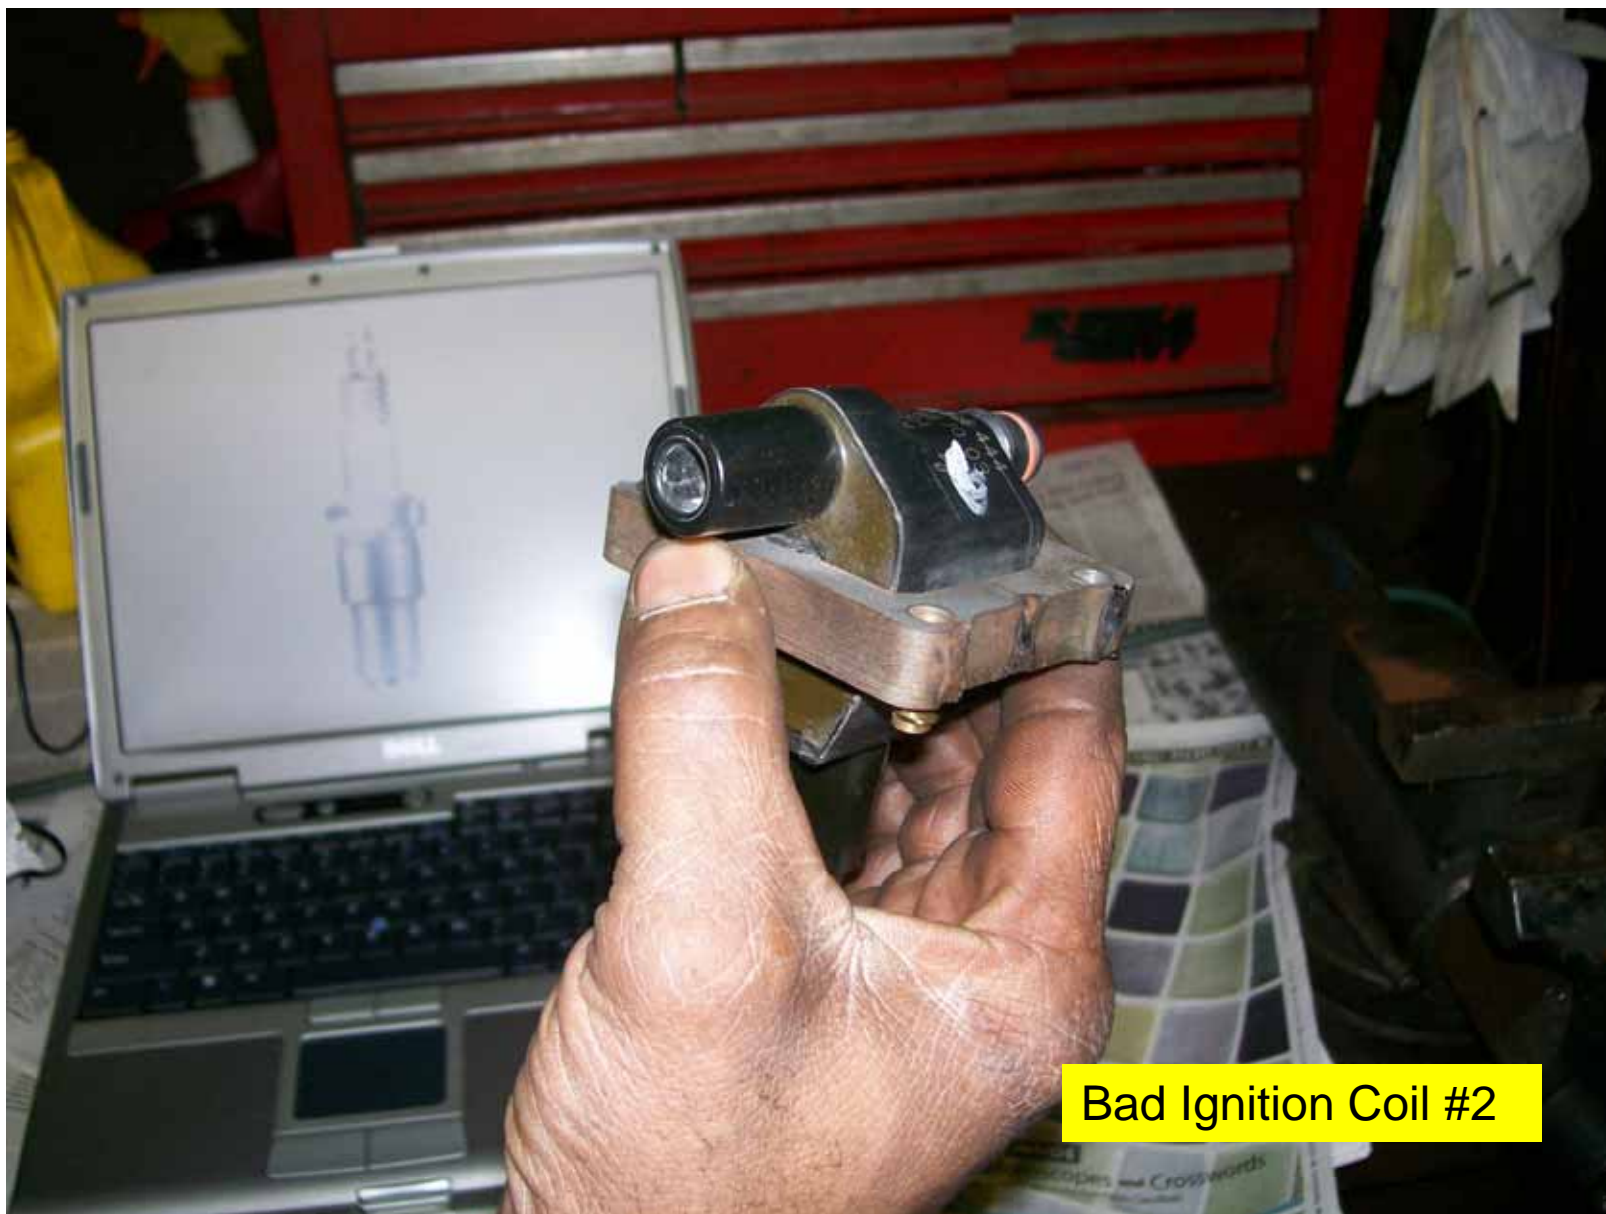
Bad Ignition Coil #2

- The fix was the replacement of a bad ignition coil# 2.
- There were no visual signs of damage to the coil.
- A labscope pattern show no signs of failure per a primary current waveform.

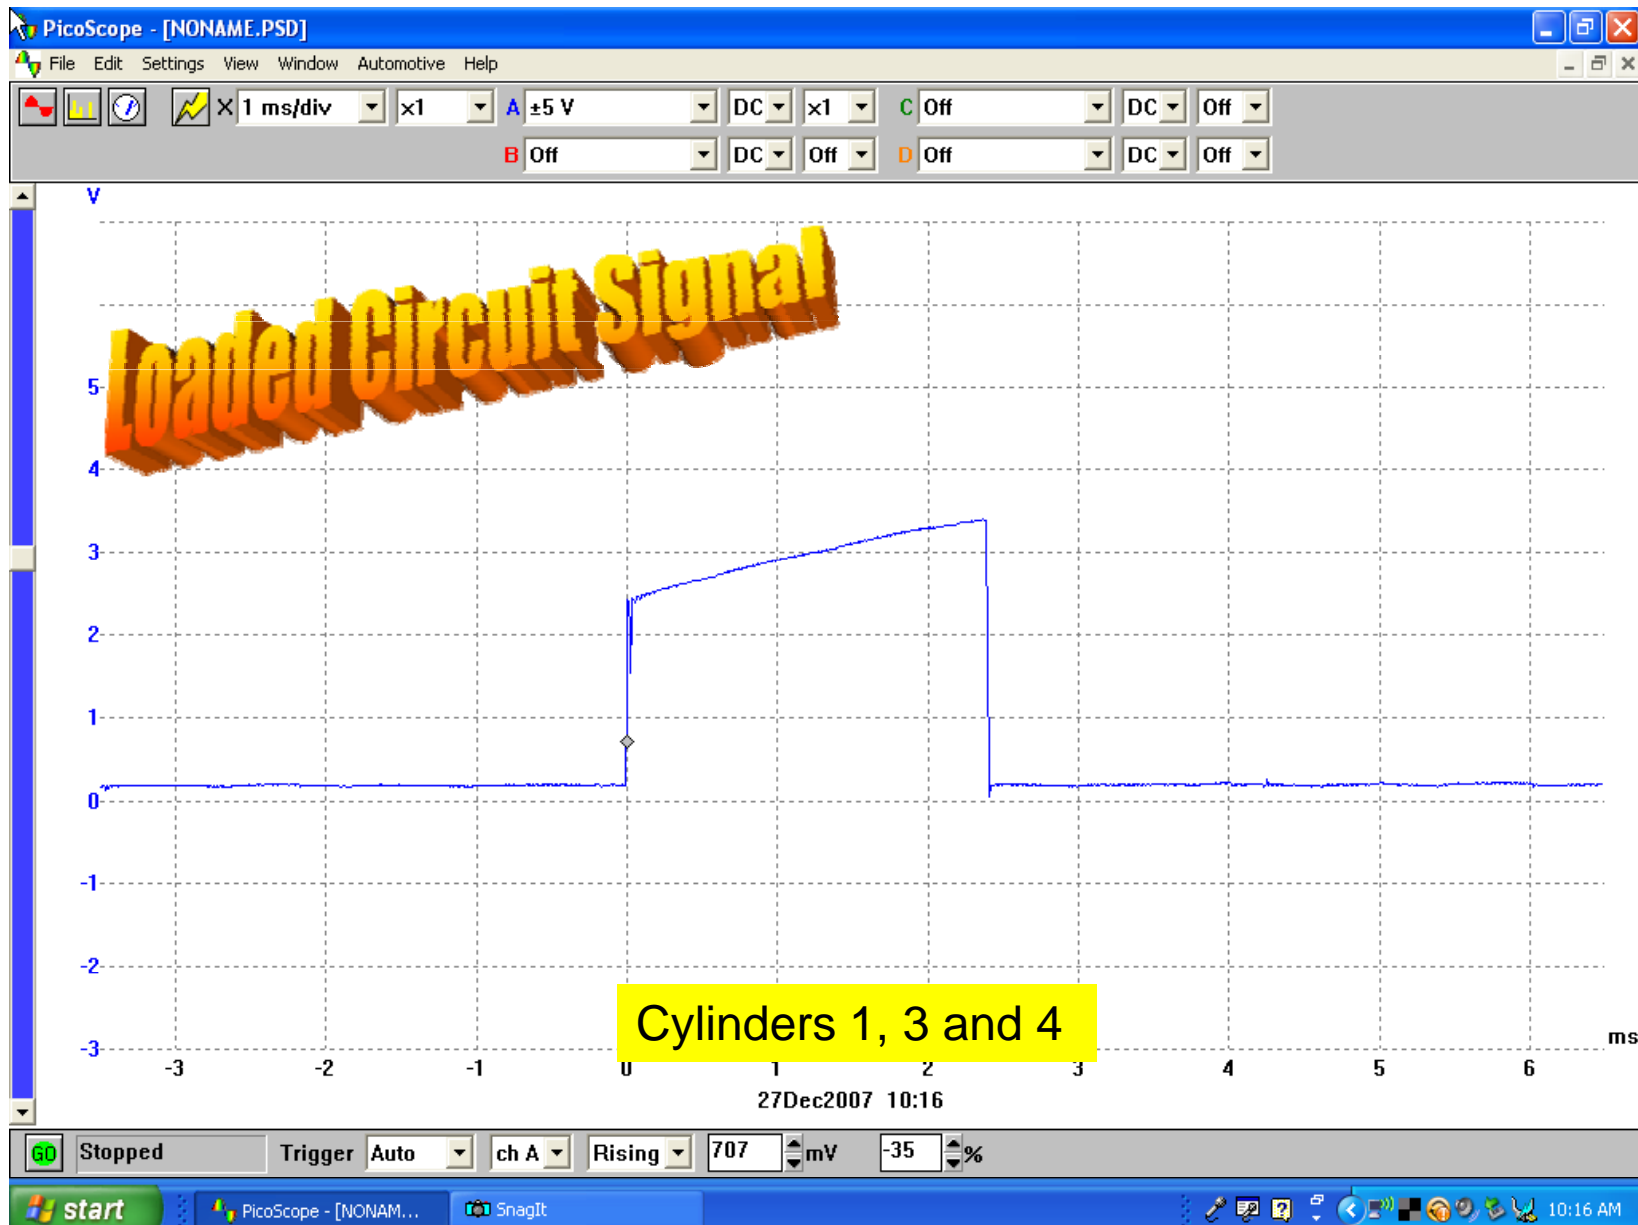
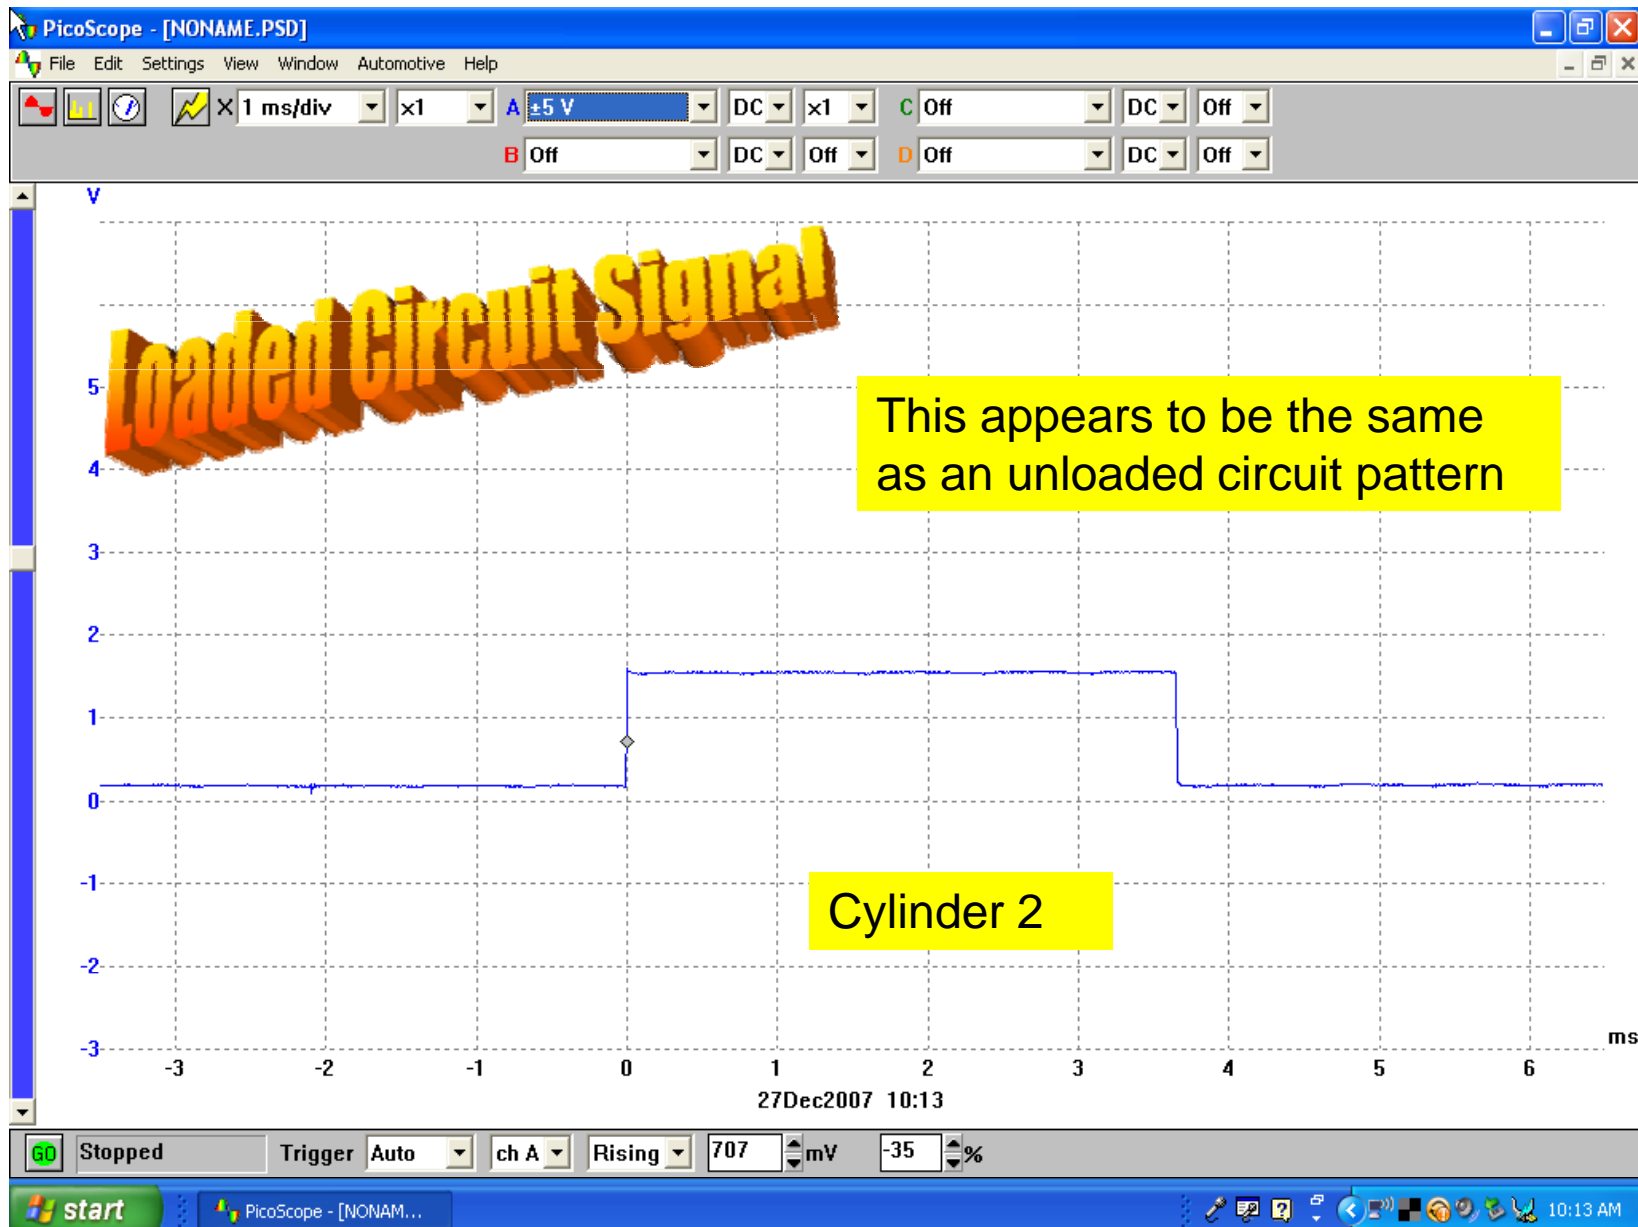
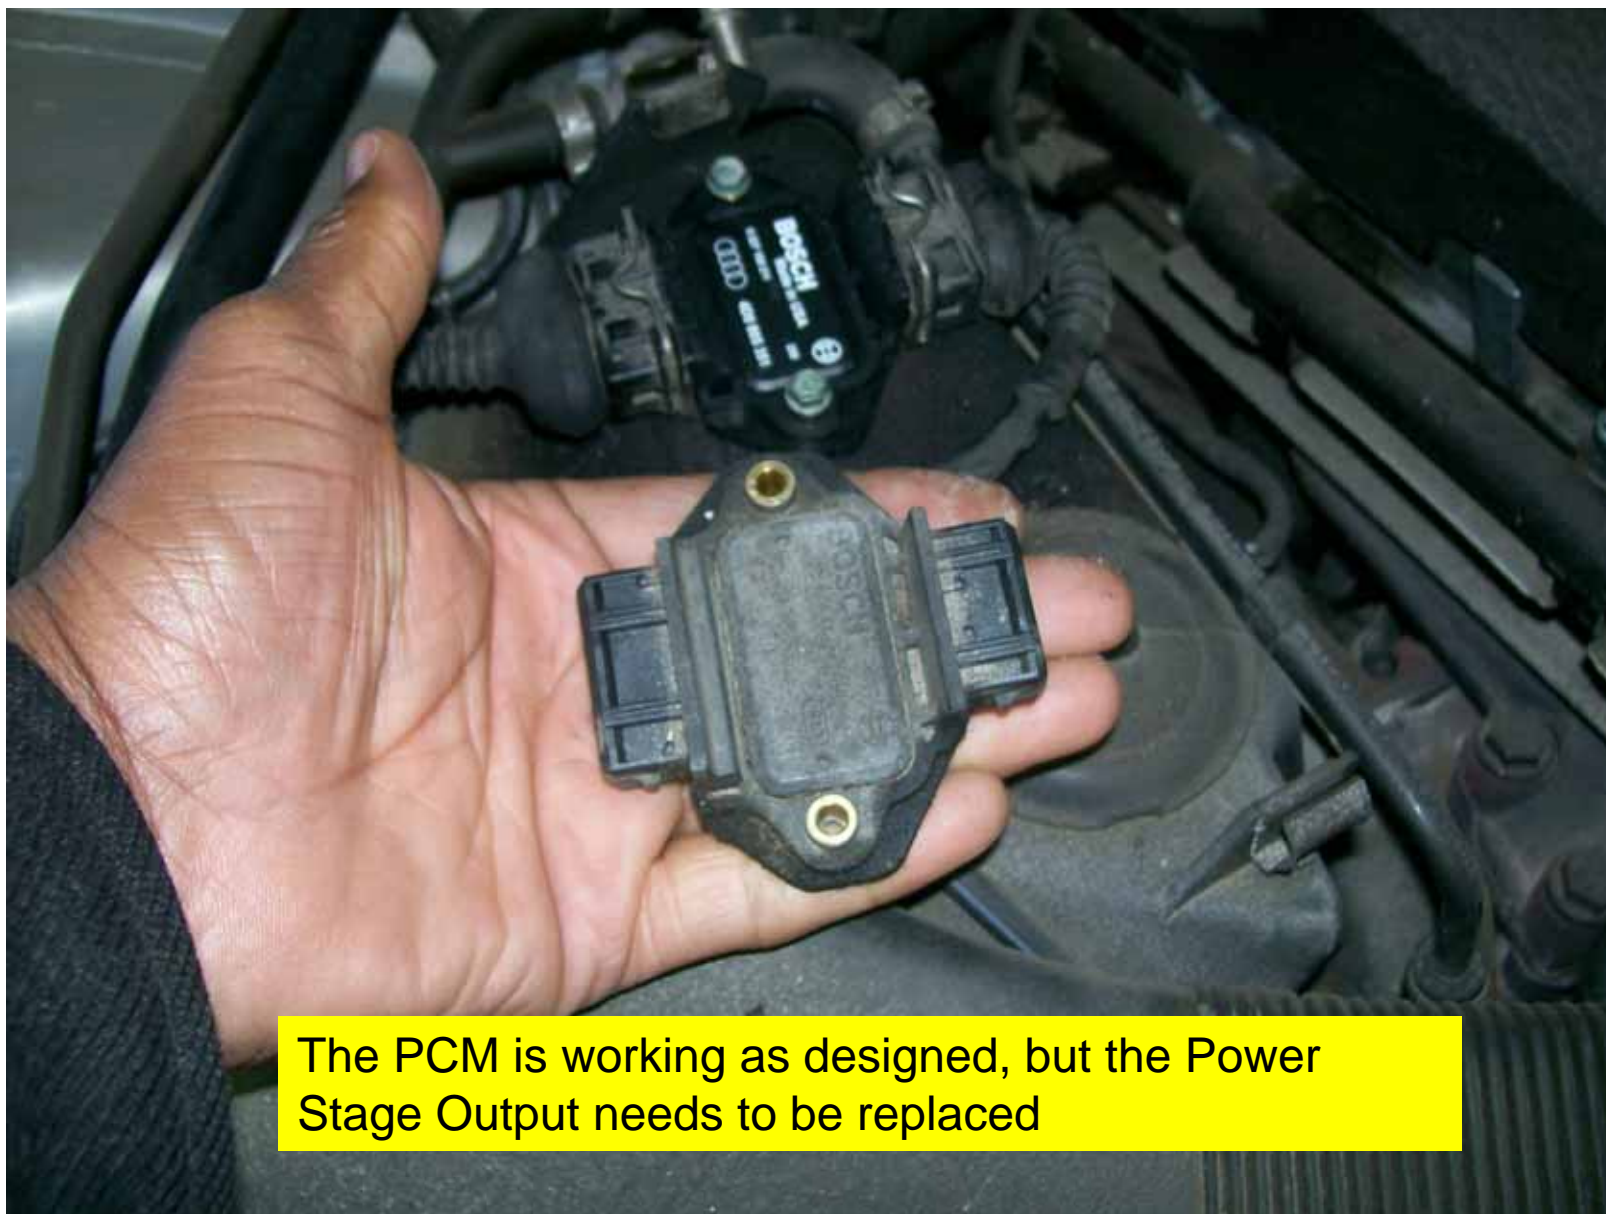
- Cylinders 1,3 and 4 showed good loaded circuit PCM ignition trigger patterns
- Cylinder 2 pattern looked the same as the unloaded circuit pattern
- The *Power Output Stage* is what provides the loading effect for this circuit

The PCM is working as designed, but the Power Stage Output needs to be replaced

- The Power Stage Output was replaced and the vehicle is now operating as designed.
