Fuel Trim and Misfire Analysis

A “No Excuse” Approach

1997 Buick Park Av

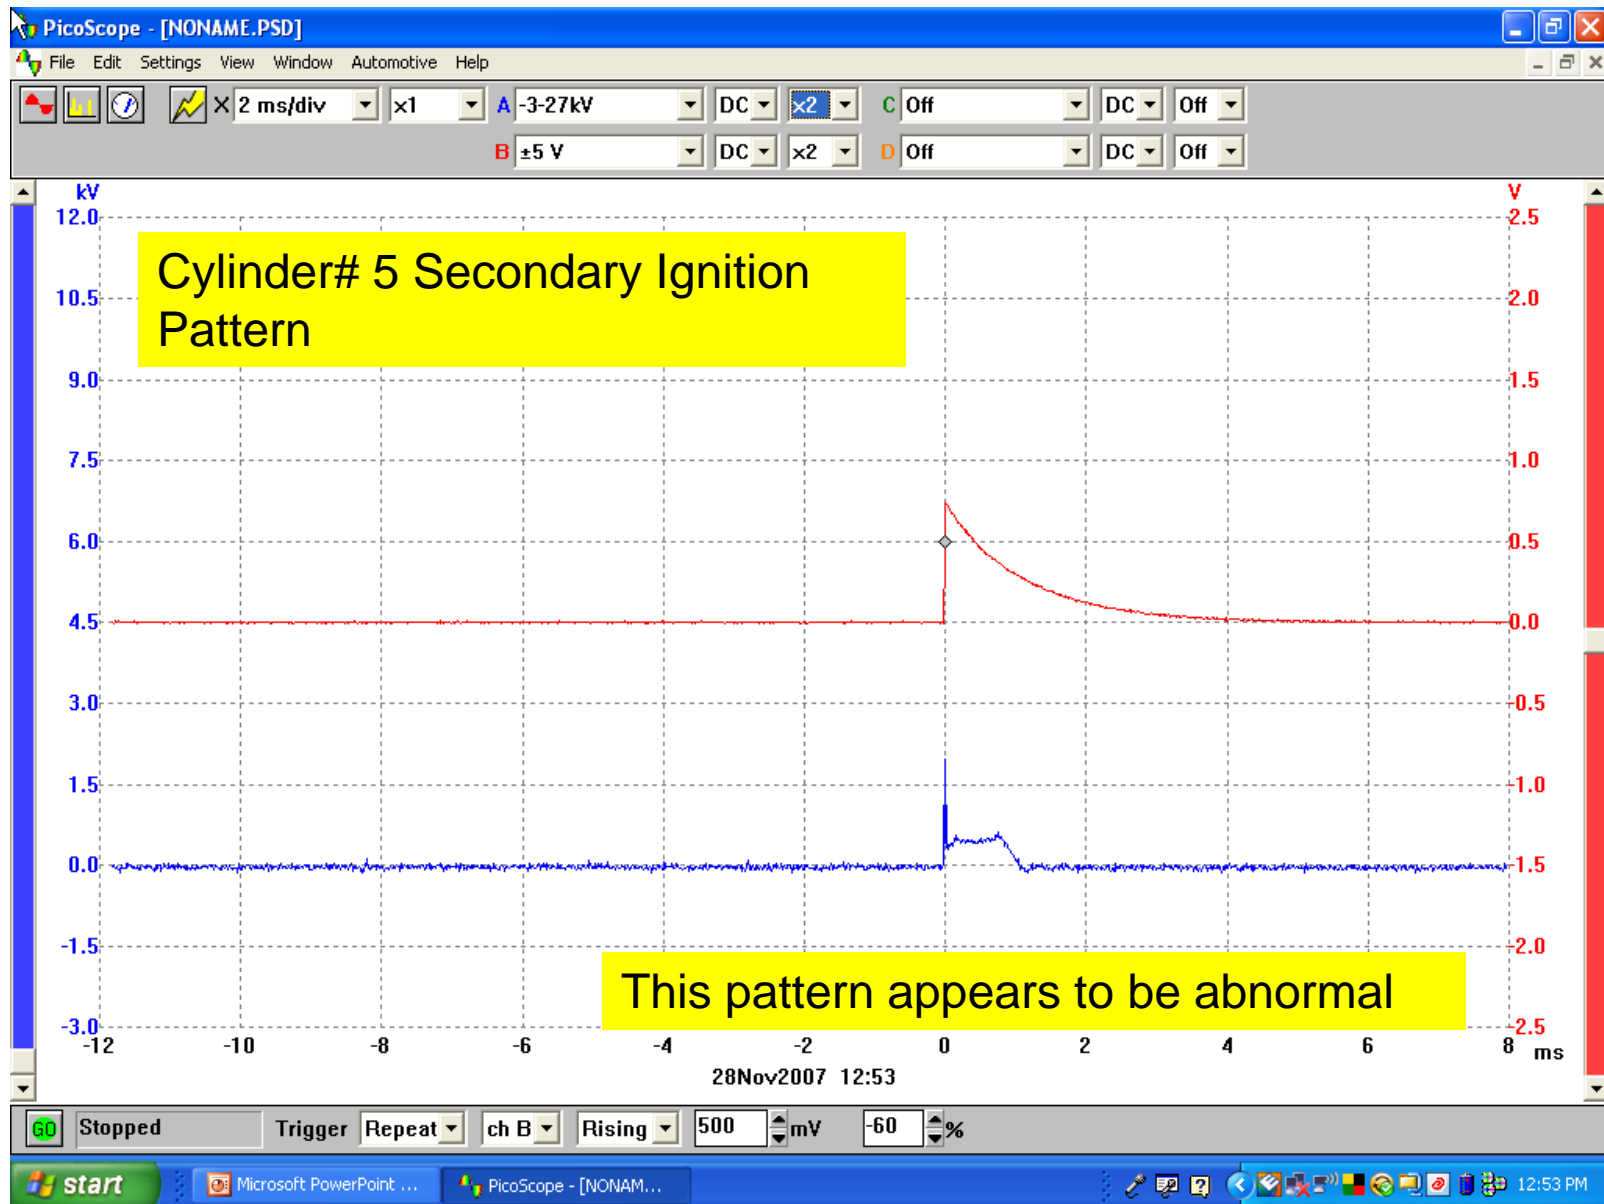
1997 Buick Park Av

- The ignition wire was checked and passes its test
- A visual of the spark plug indicated it to be at a failure status

Cylinder# 5 has a Fouled Spark Plug

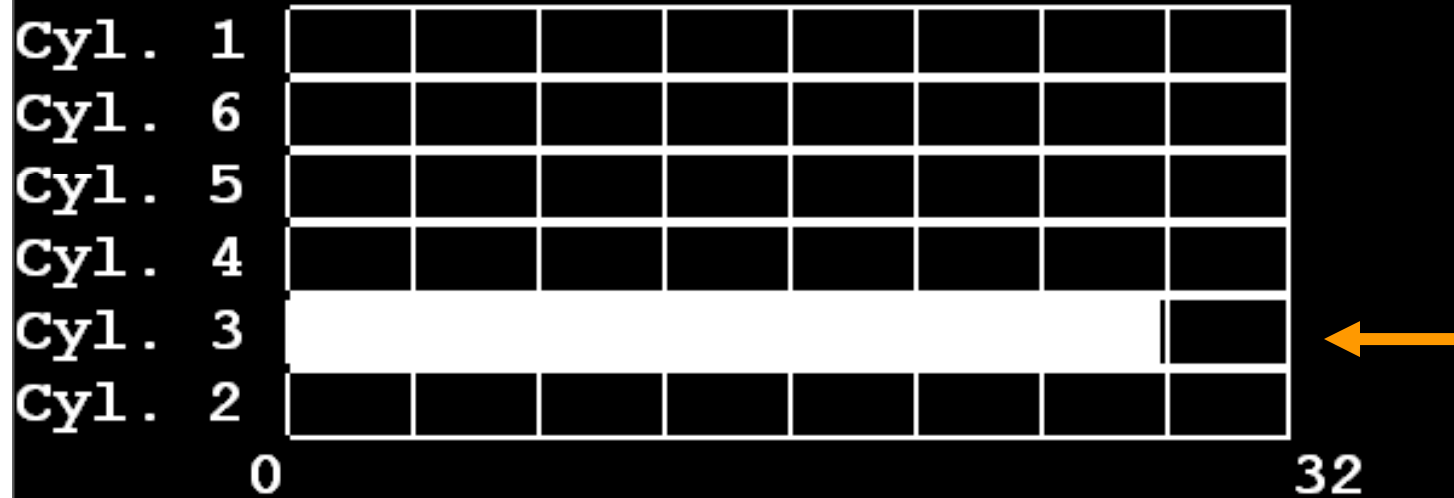
Misfire Graphic

- Misfire activity on cylinder #1 and #5 has been corrected
- Cylinder #3 alone now shows consistent misfire activity on the Tech 2 scantool
- Time to review fuel trim and vacuum readings again

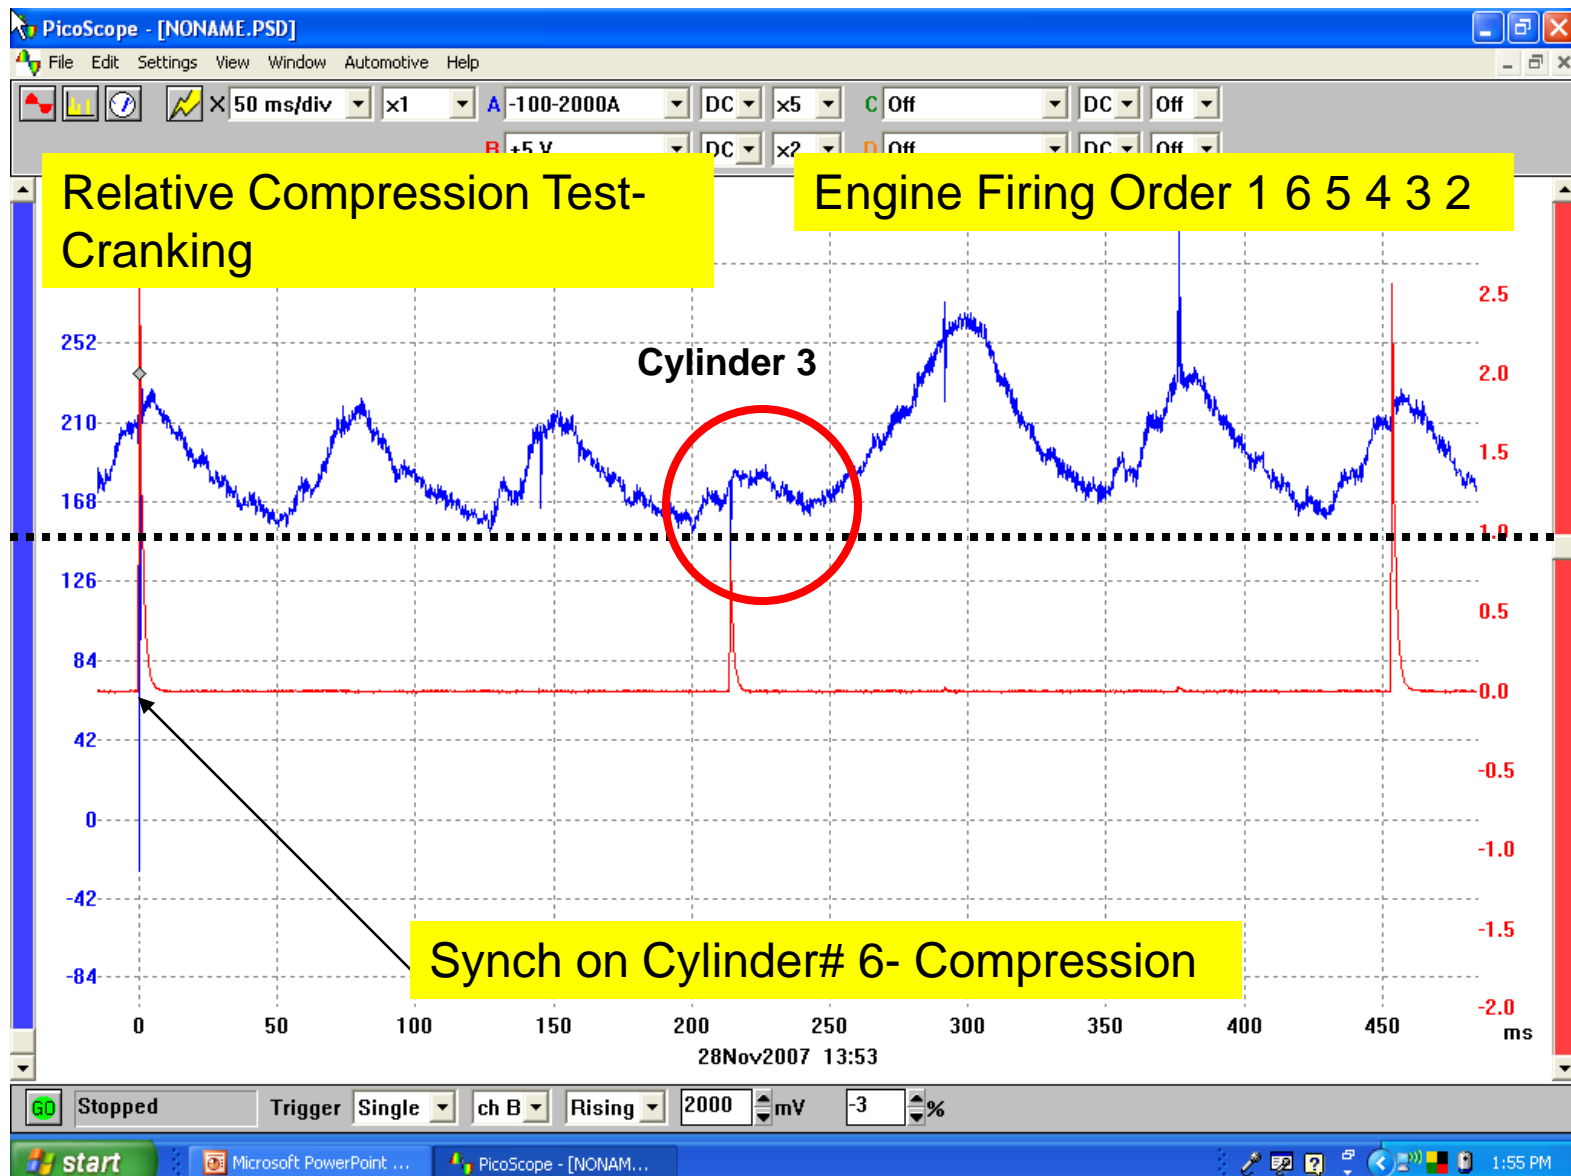
Relative Compression Test

- If you get this activity, you should run a compression test on that cylinder right away
- The crankcase vacuum should also be checked as well as engine vacuum

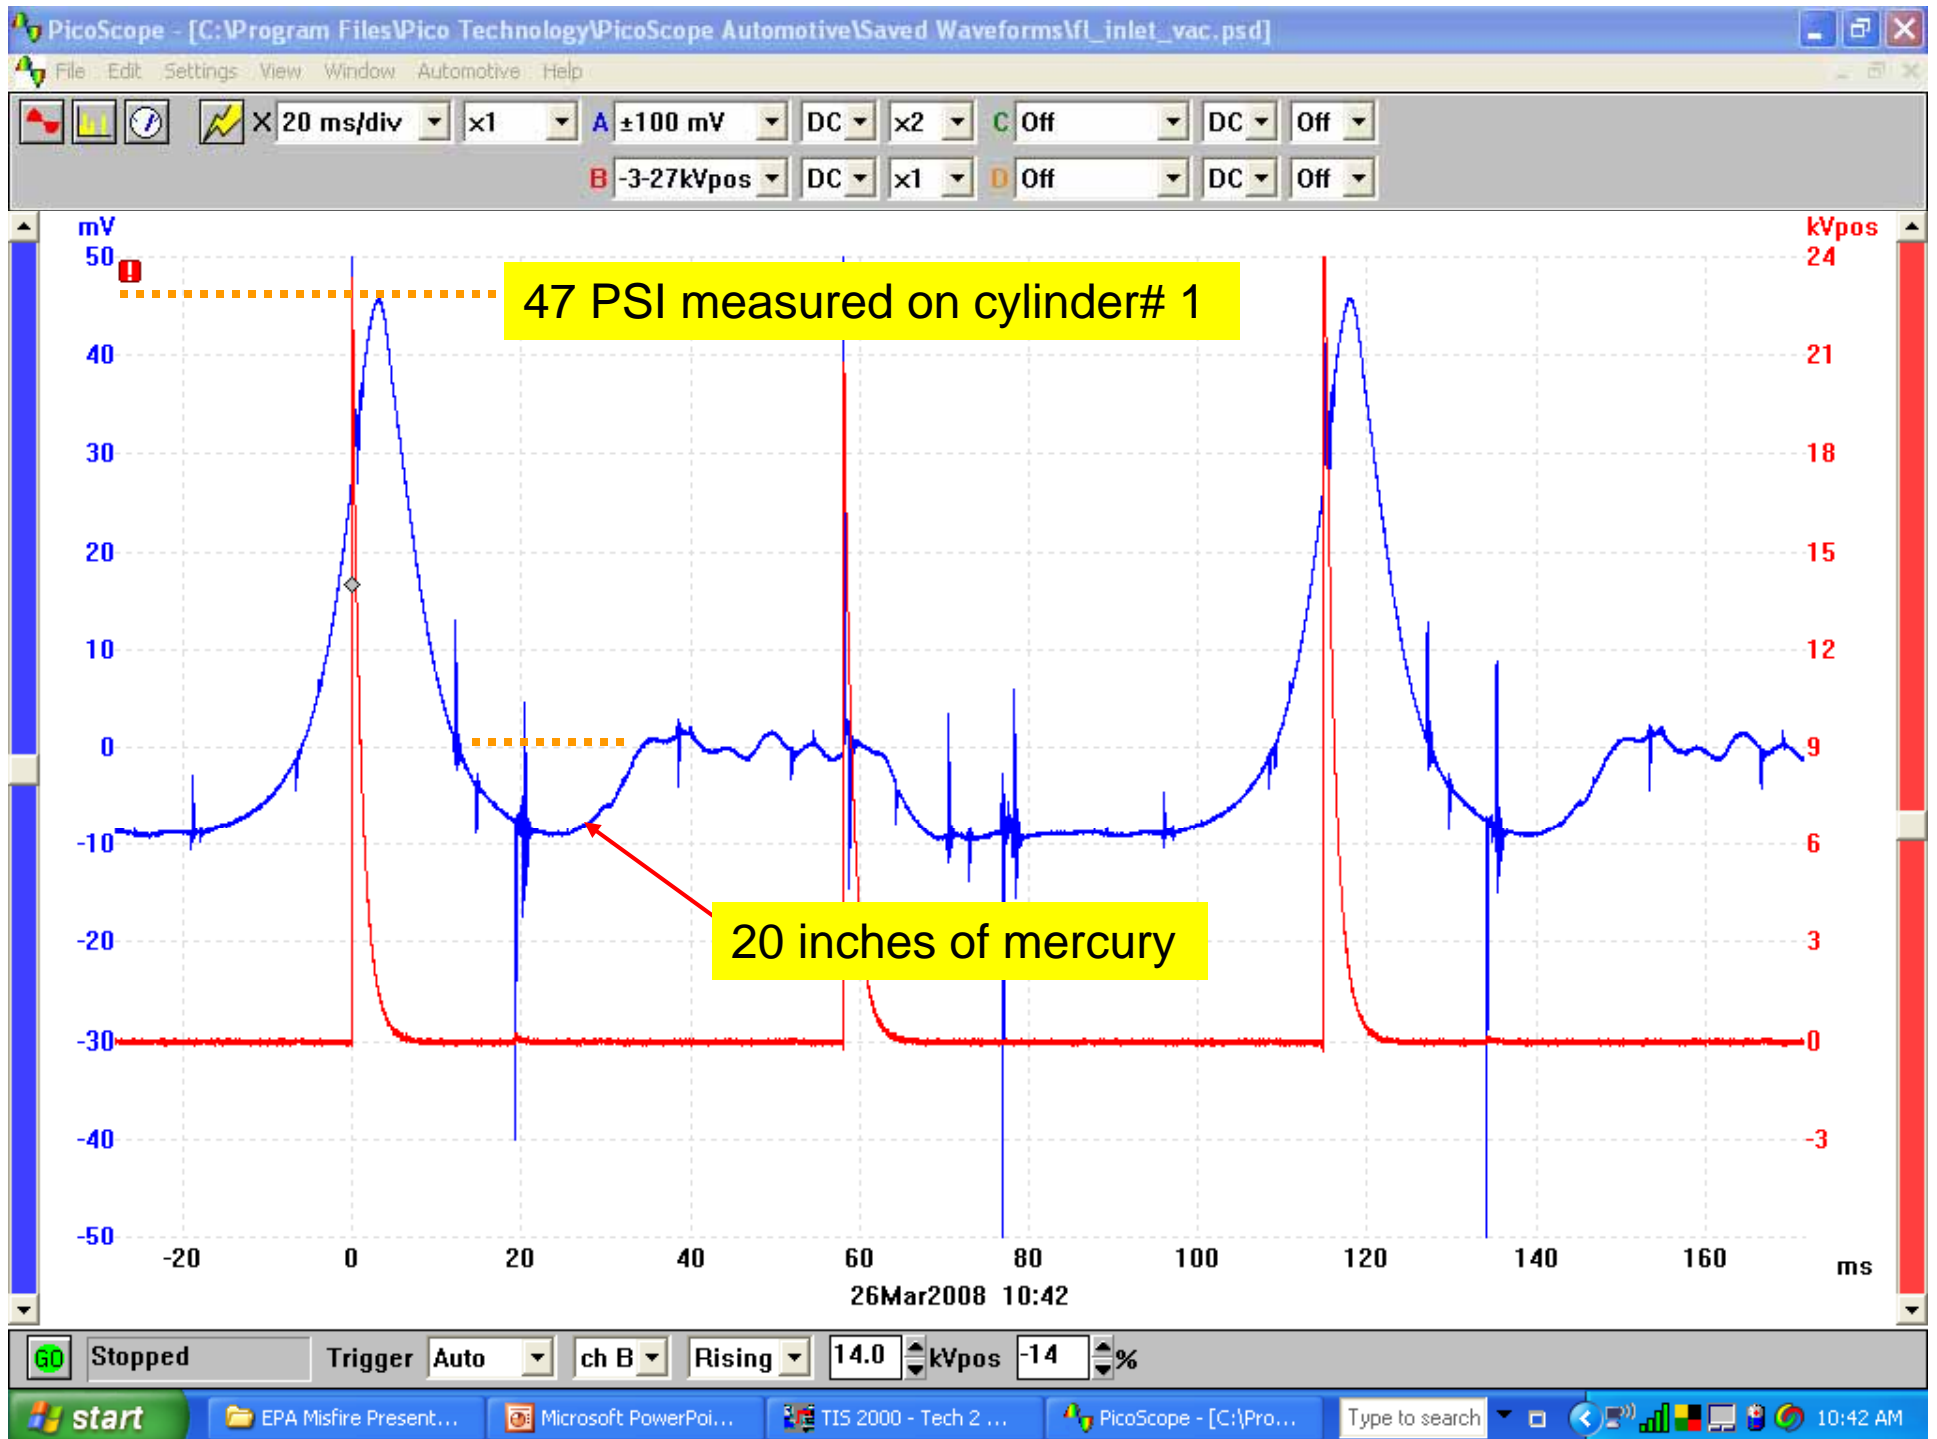
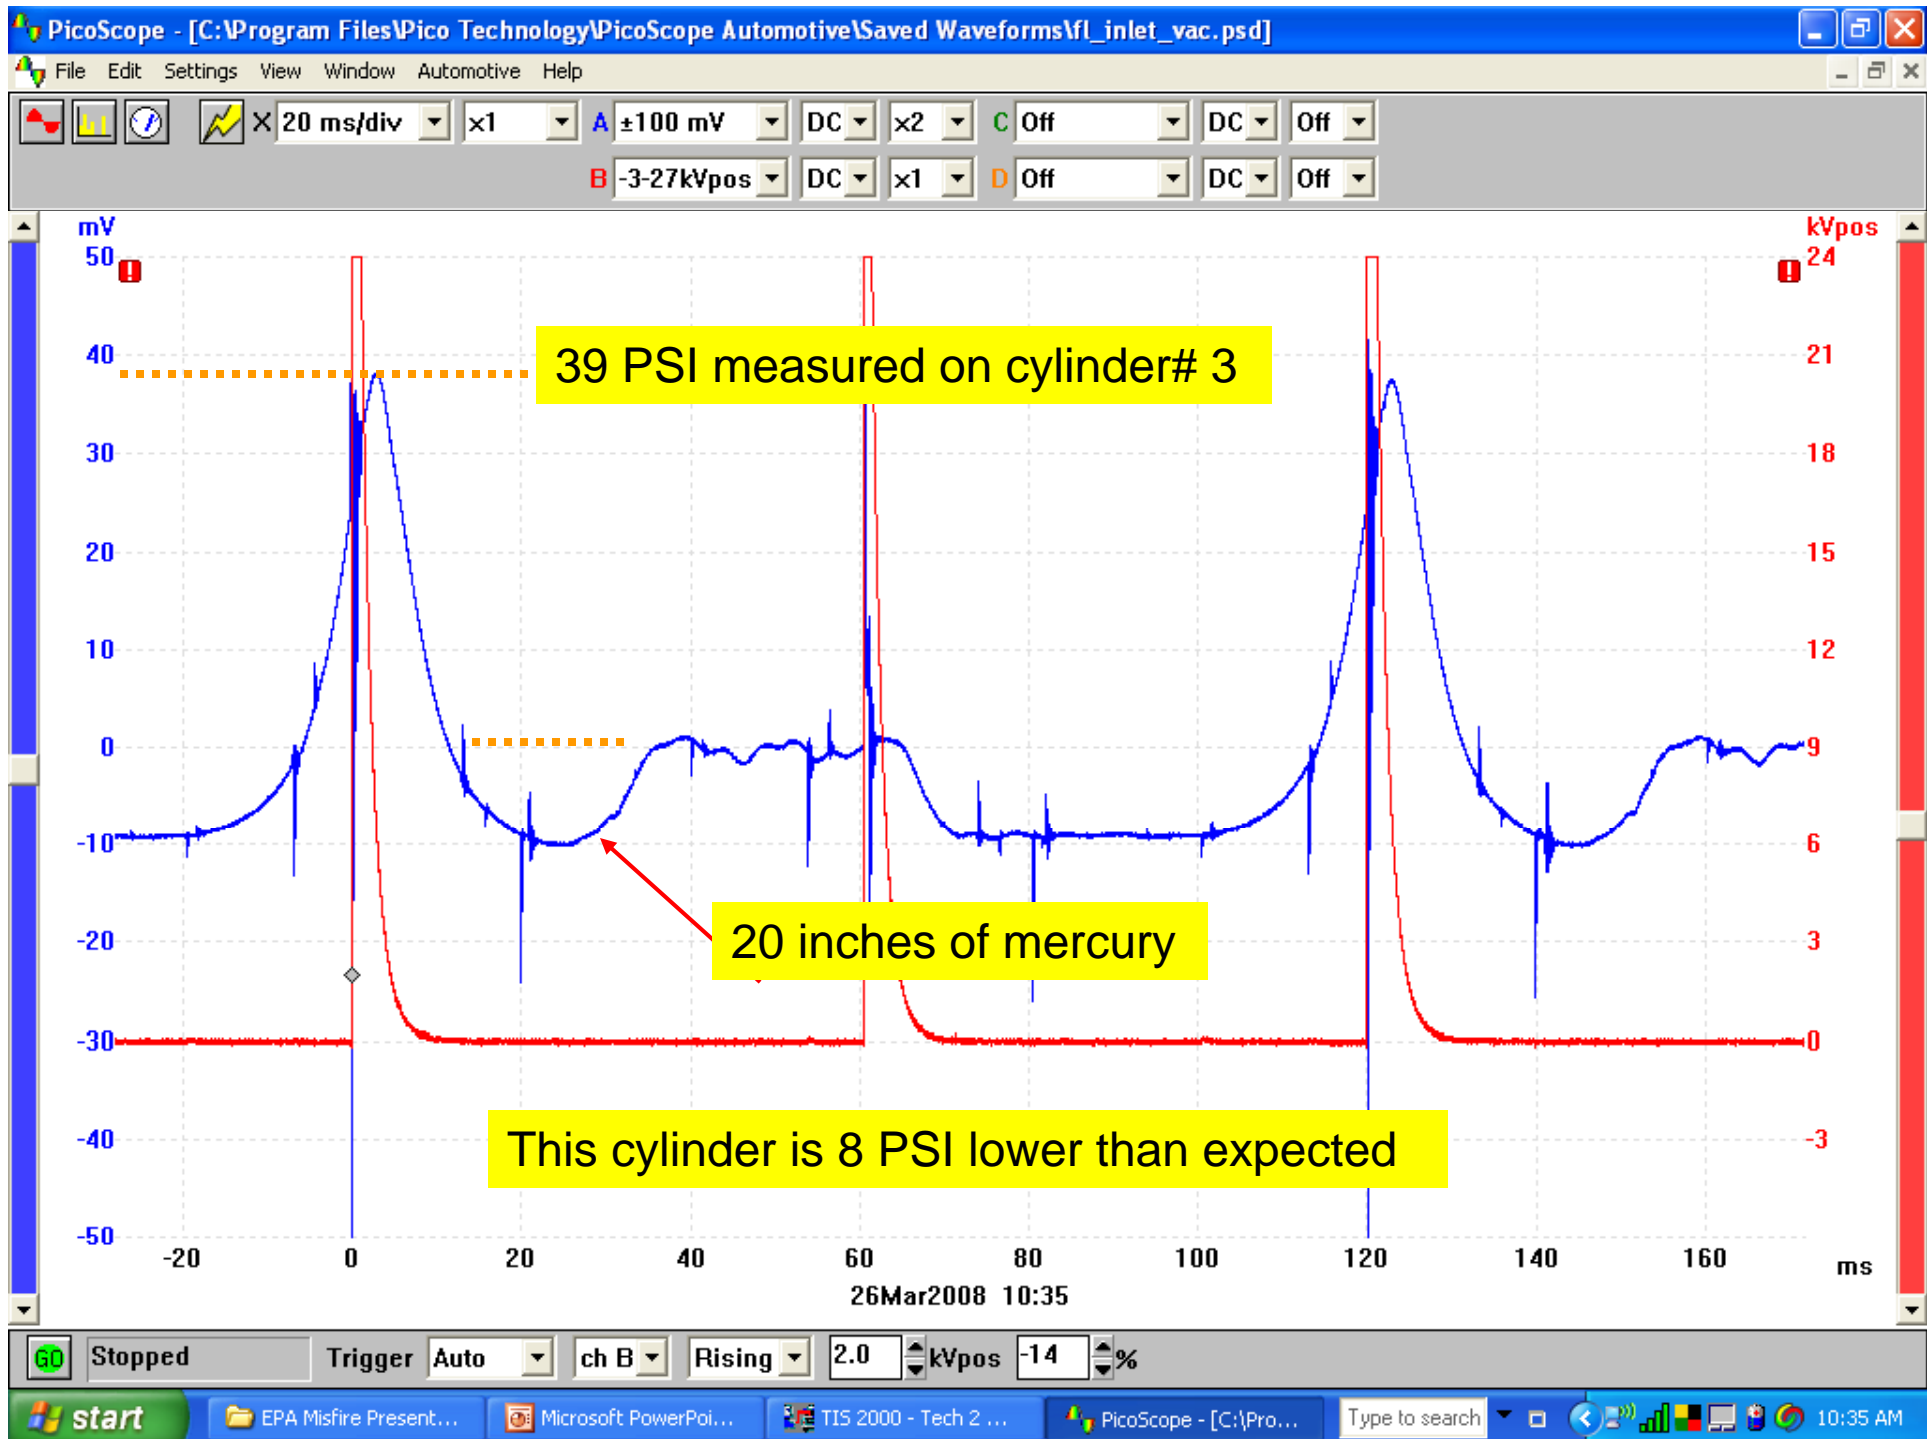
- There is about 5 PSI in the manifold with the engine running
- The amount of pressure in the cylinder is equal to $9.4 \times 5 \text{ PSI} = 47 \text{ PSI}$
- This is the amount of pressure that should be observed with the engine running

- There are several possible suspects that may could cause this issue:
 - Valve issues
 - Piston issues

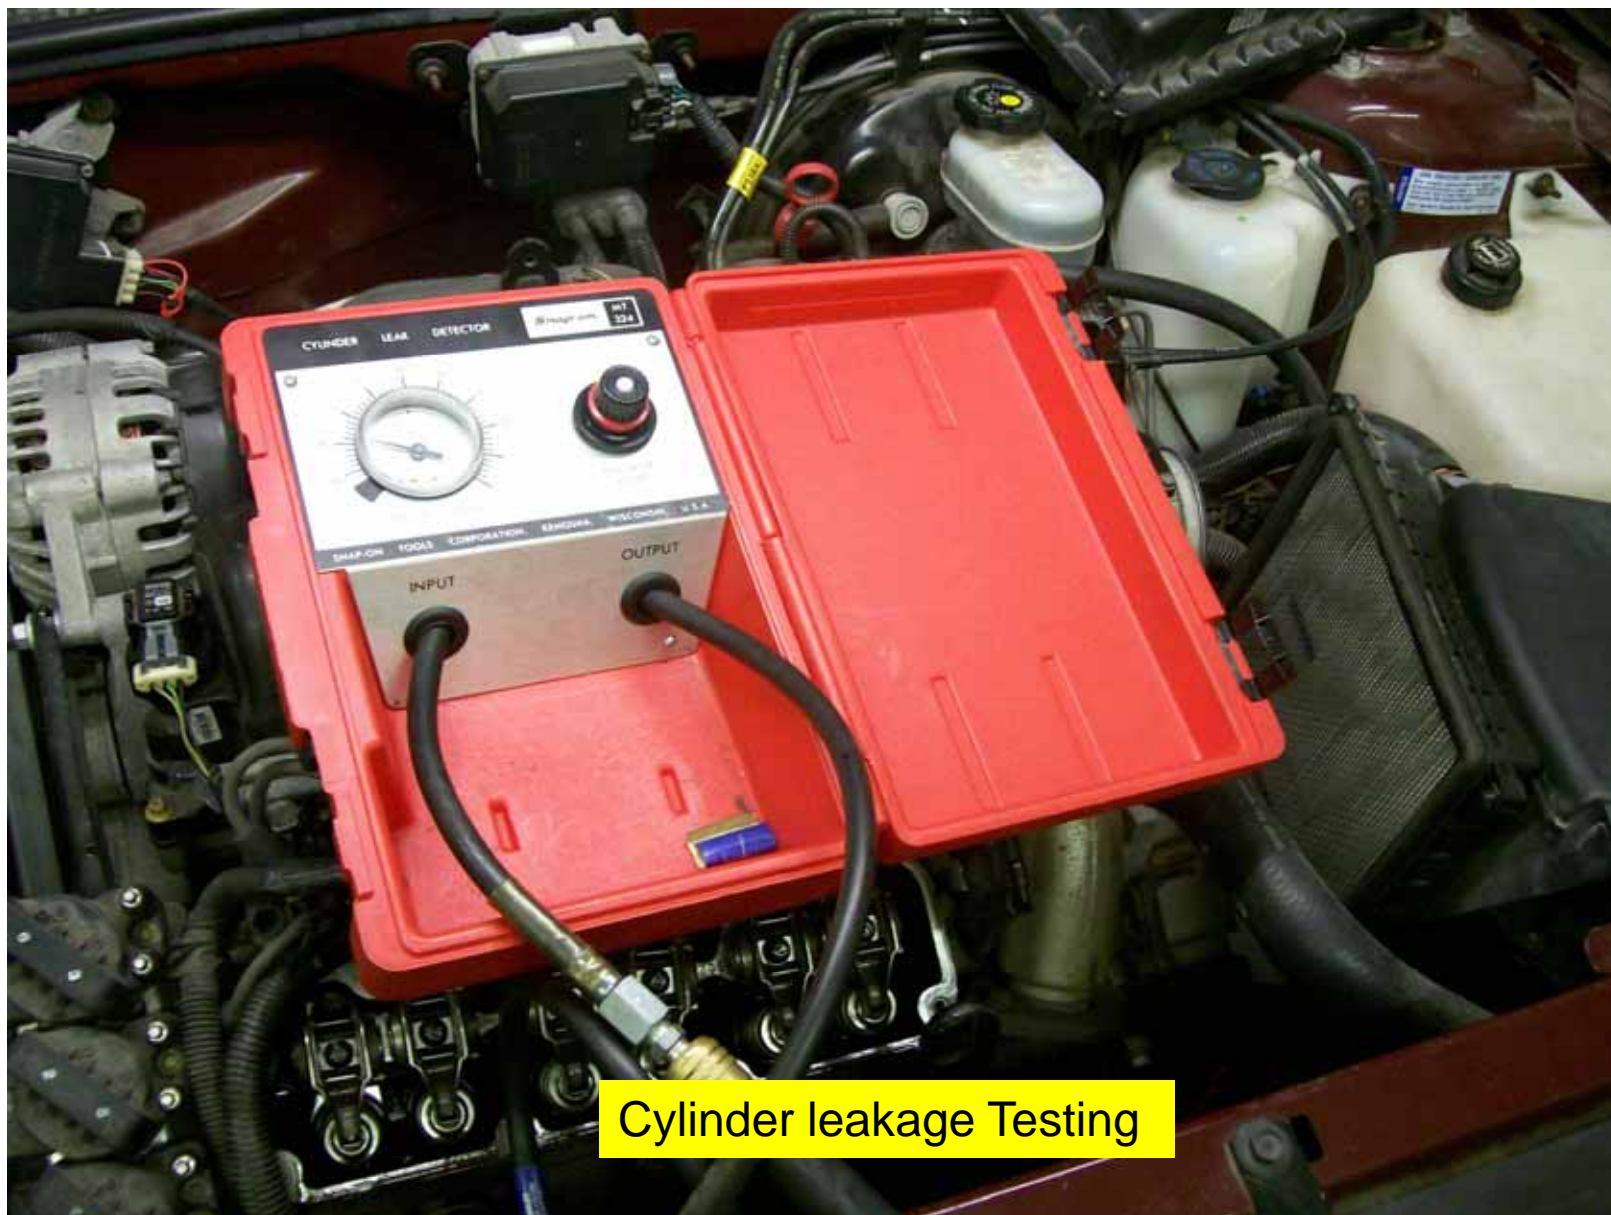
Cylinder Leakage

- A visual inspection of the cylinder revealed that the top of the cylinder piston head was cracked, thereby leading to a slight loss in compression as witnessed by the pressure waveform.

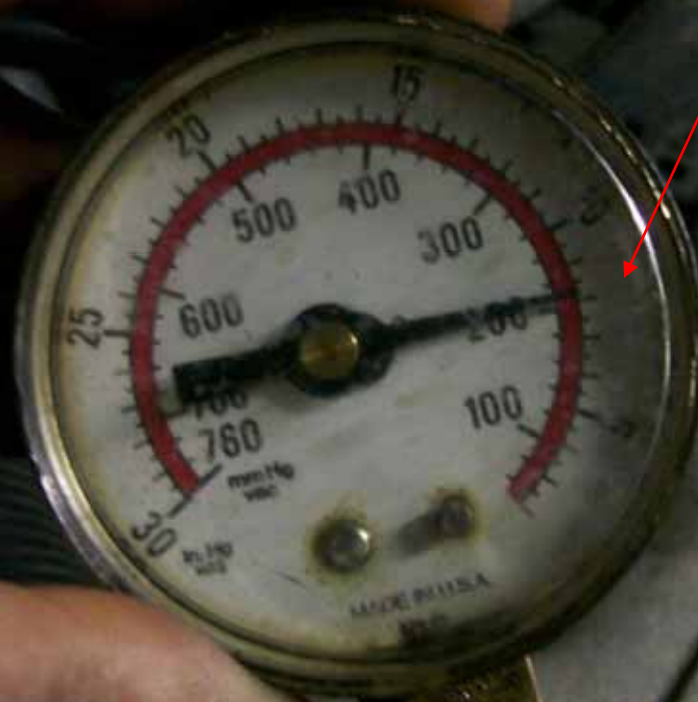
Vacuum Levels

Engine Running Vacuum Reading: 7 Inches Mercury

- This misfire activity appears to be mechanical or a vacuum leak issue.

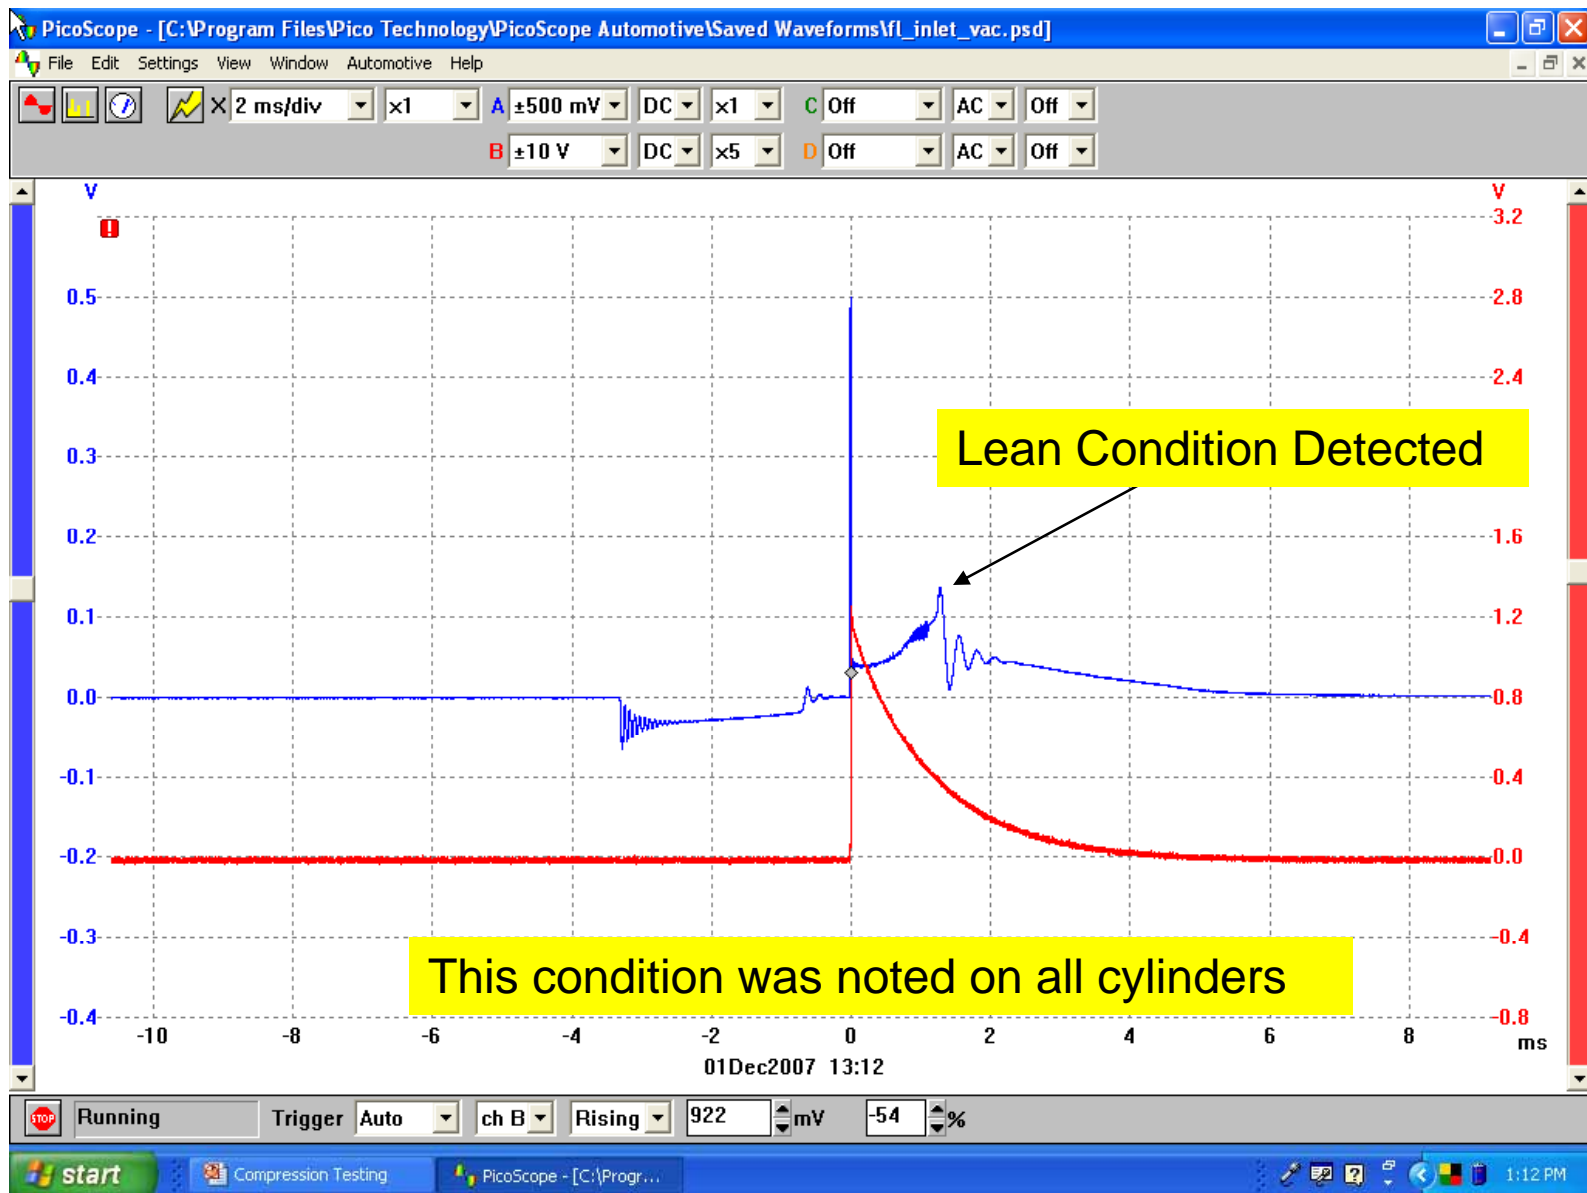
Secondary Ignition Waveforms

- A vacuum cup was placed in the intake at the air cleaner housing
- The system was then smoked for leaks
- A smoke machine should be used anytime vacuum readings are low

The intake manifold gasket was leaking as well

- The IAT sensor and PCV valve hose assembly were replaced
- The intake manifold gasket was replaced as well
- The vehicle is now operating as designed

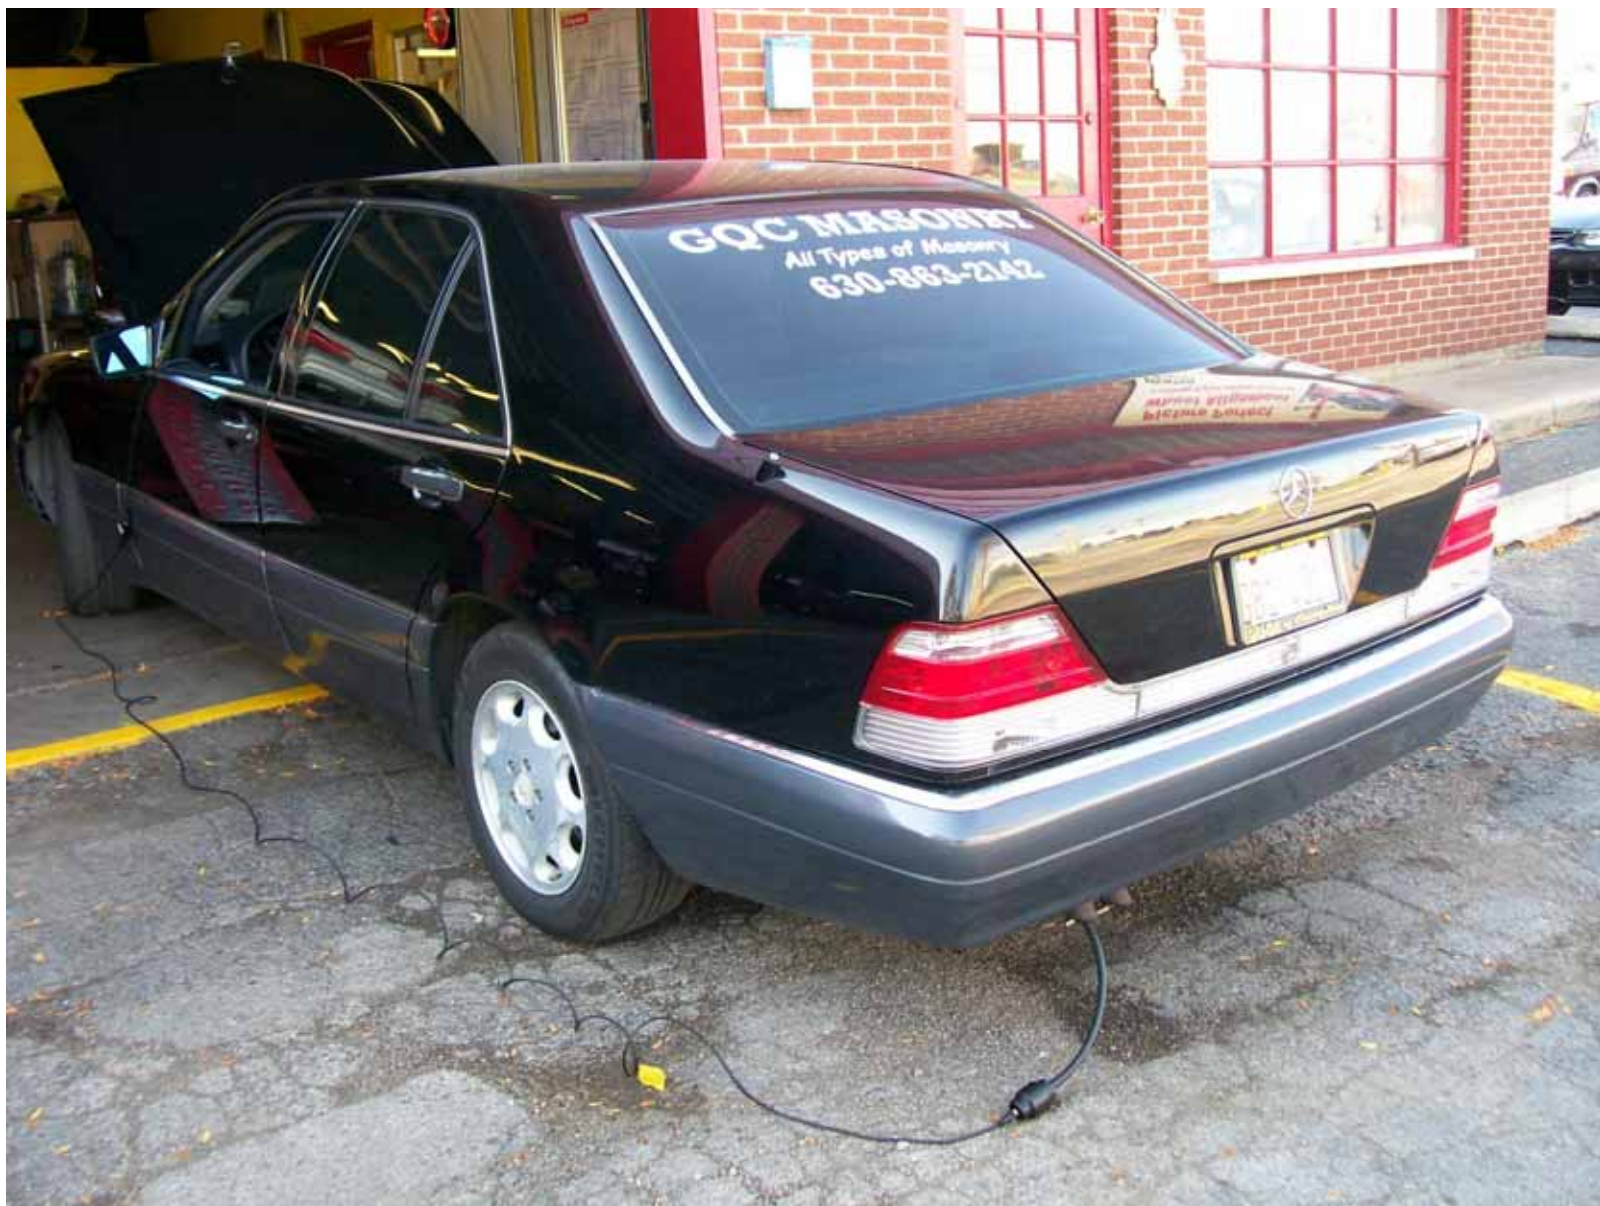
1996 Mercedes Benz

- A single cylinder misfire is occurring.
- All trouble code information has been cleared by the repairing technician.
- The scantool shows that the 2-5 coil pair has a spark duration of 2.5 ms.
- The technician states the miss occurs on cylinder# 6

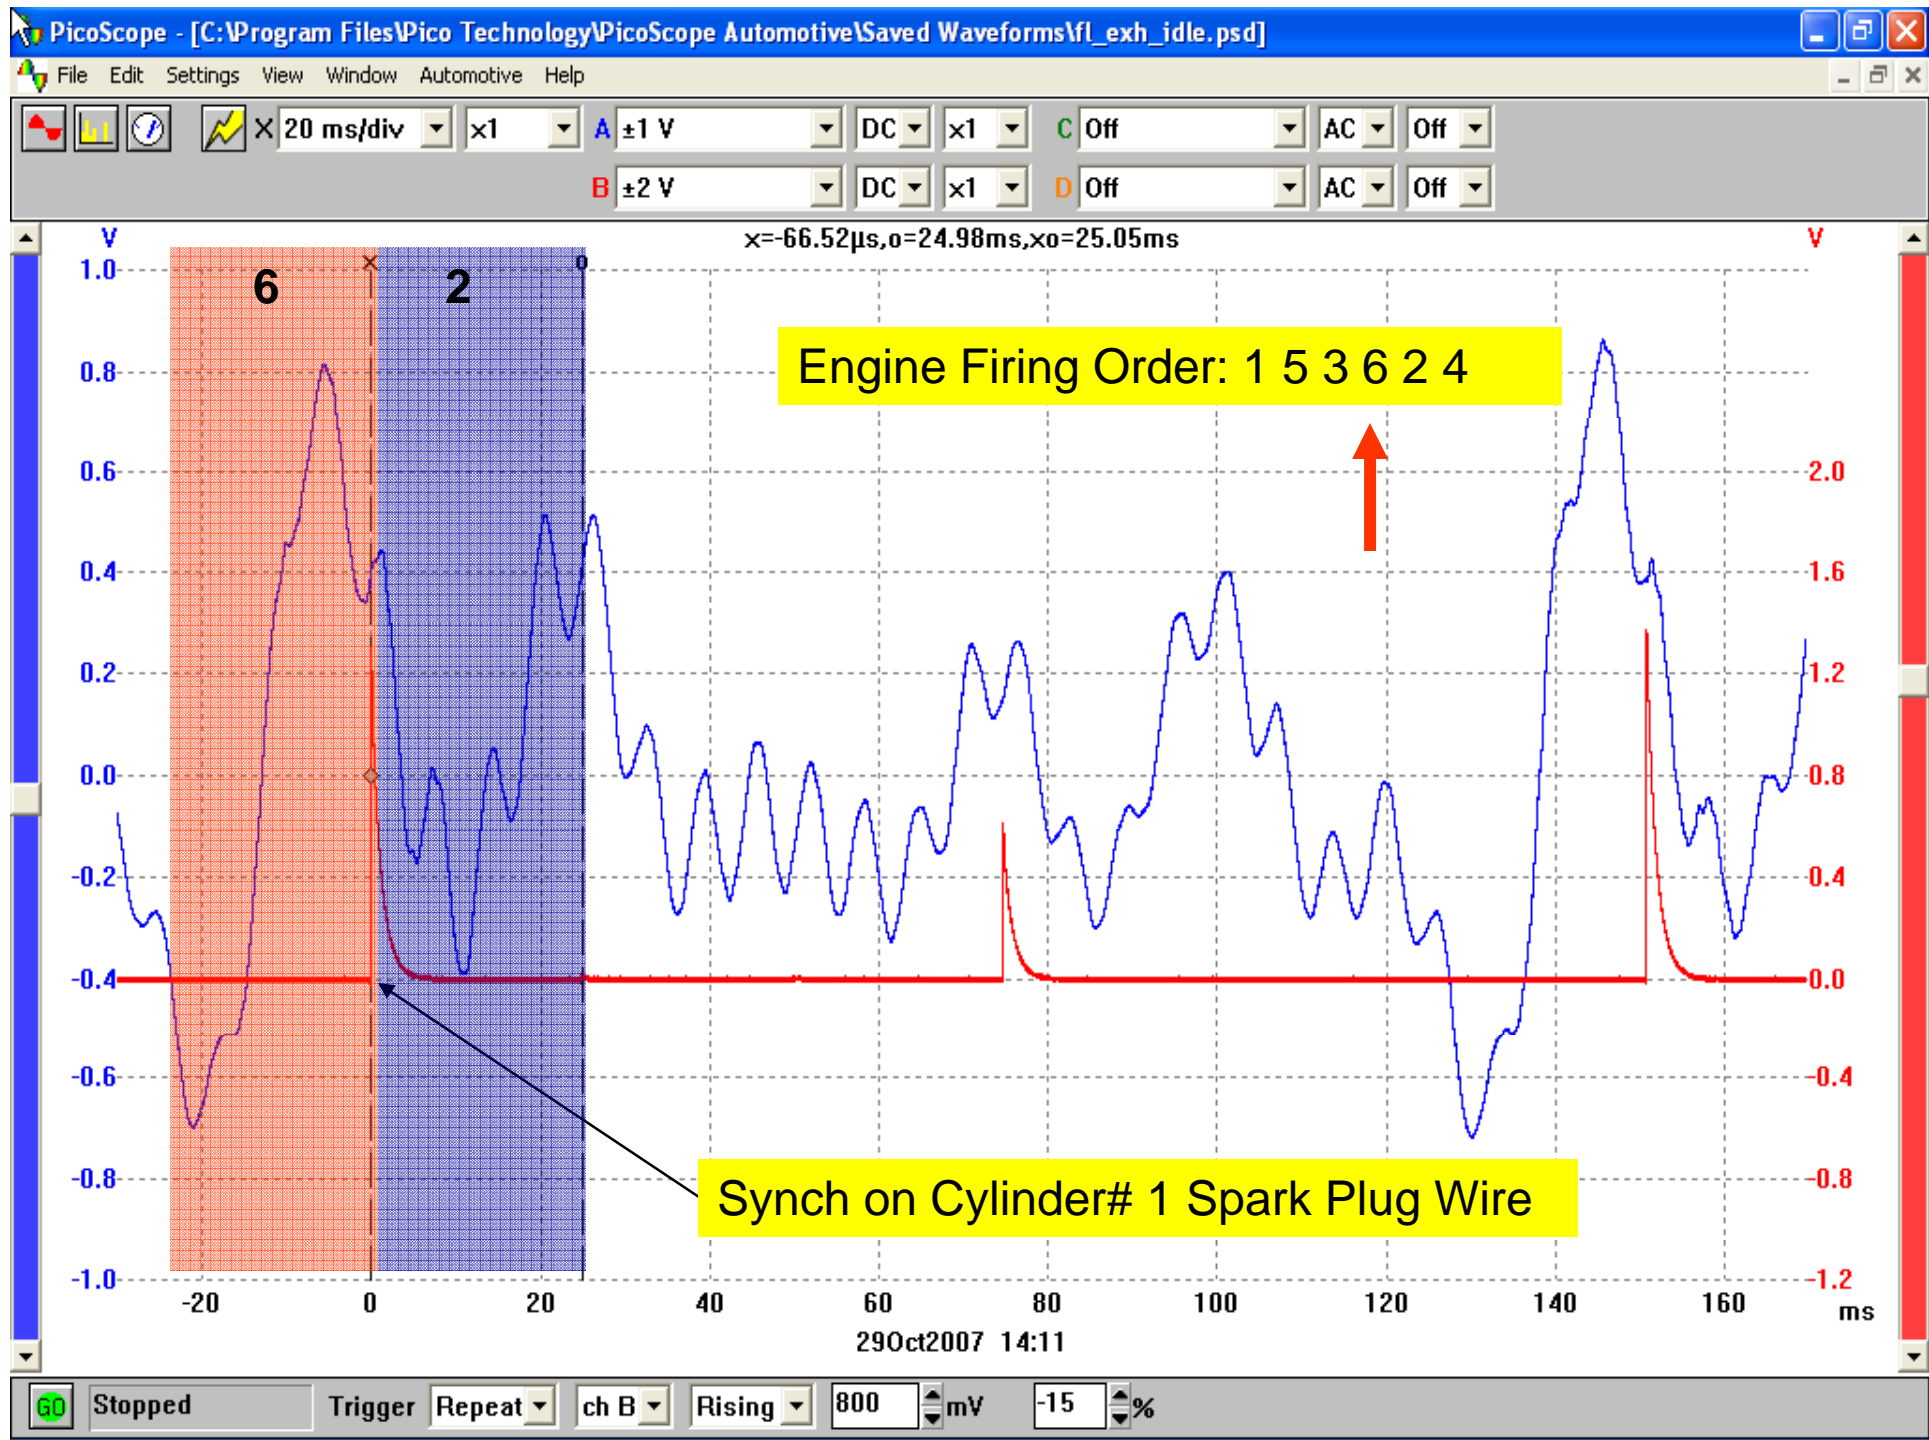
- The fix was the replacement of a bad ignition coil# 2.
- There were no visual signs of damage to the coil.
- A labscope pattern show no signs of failure per a primary current waveform.

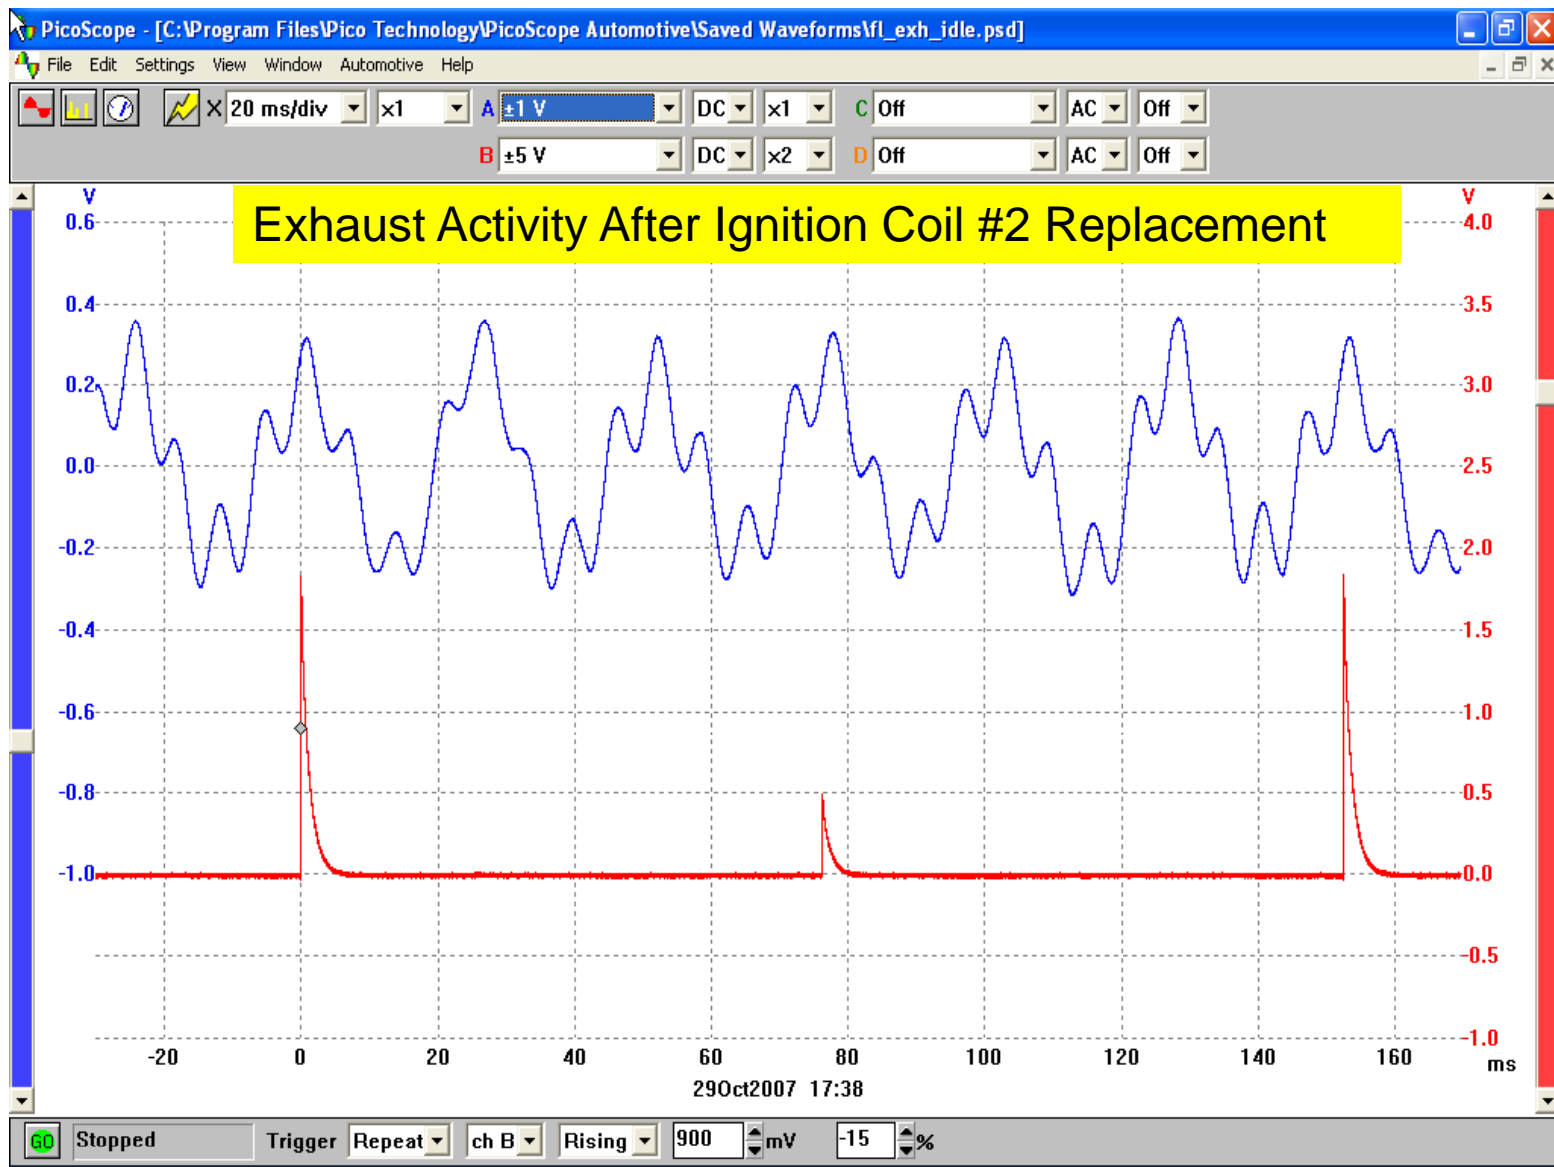
Bad Ignition Coil #2
