Fuel Trim and Misfire Analysis

A “No Excuse” Approach

1997 Buick Park Av

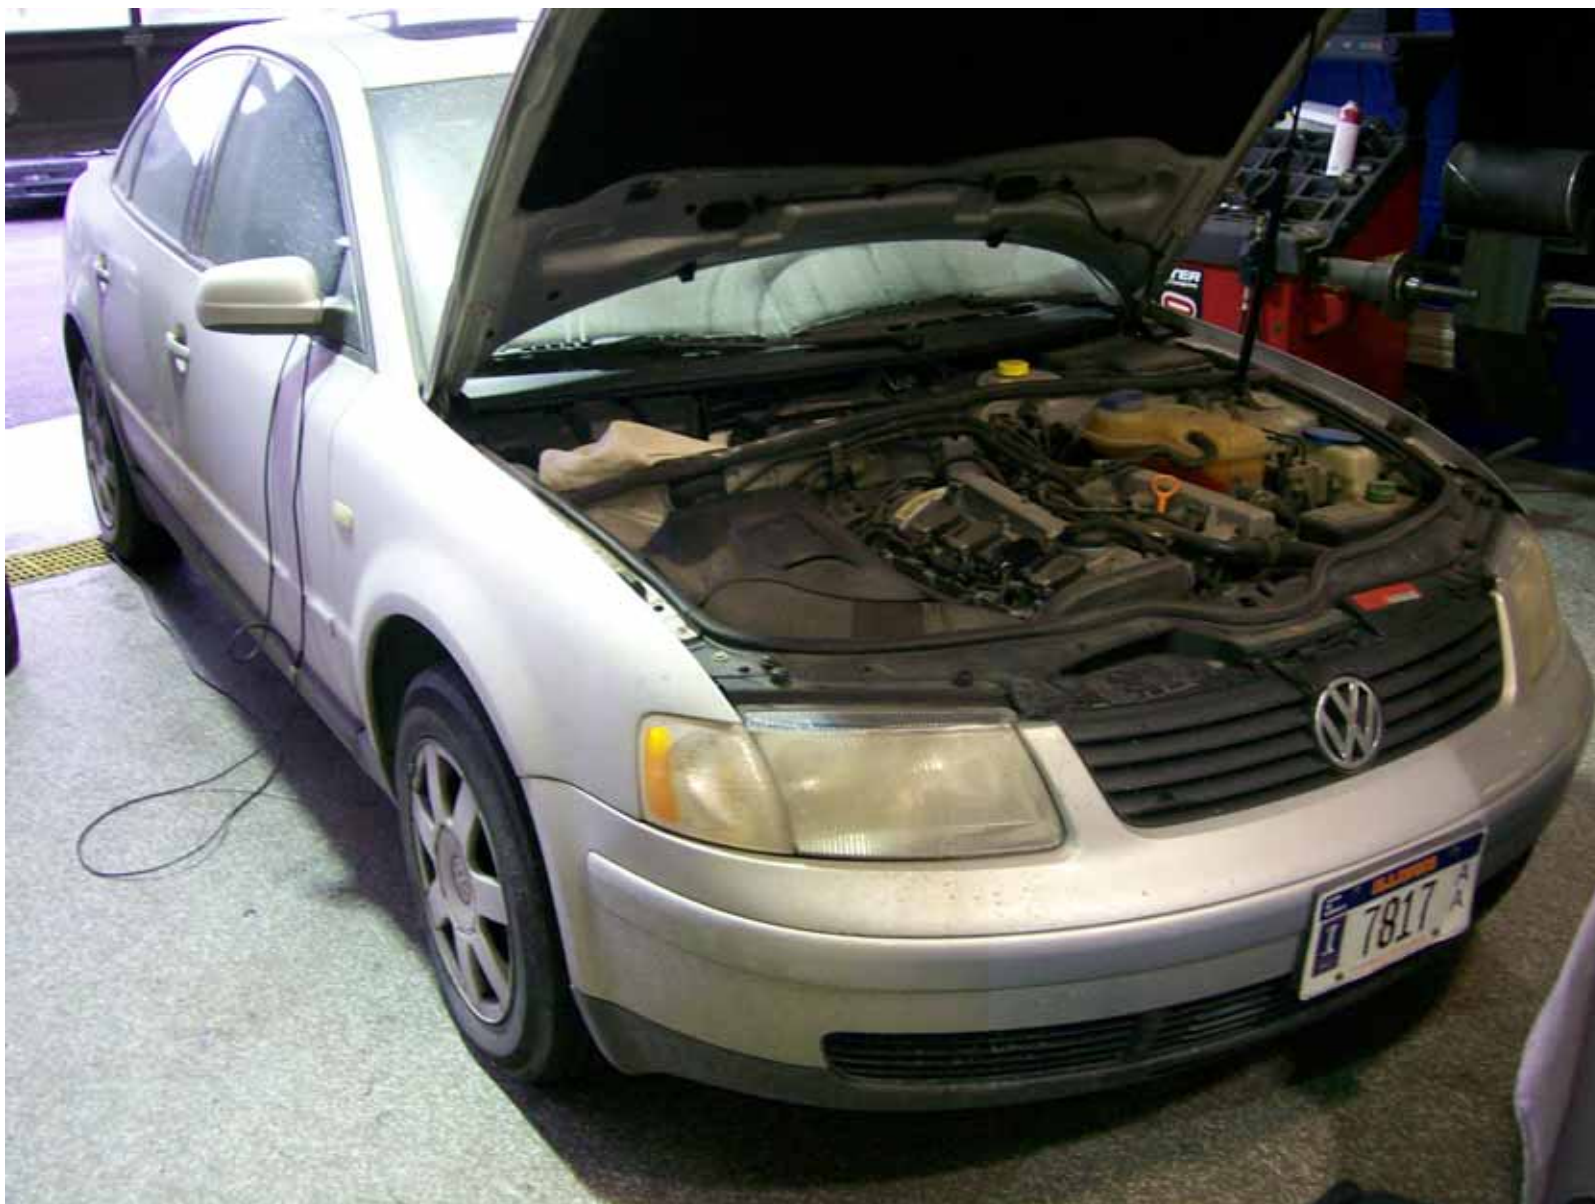
1999 Volkswagon Passat

- Vacuum level is at 17 inches mercury.
- There appears to be no misfire activity as stated by the customer
- The vehicle is run for a long period of time to see if we can confirm misfire activity

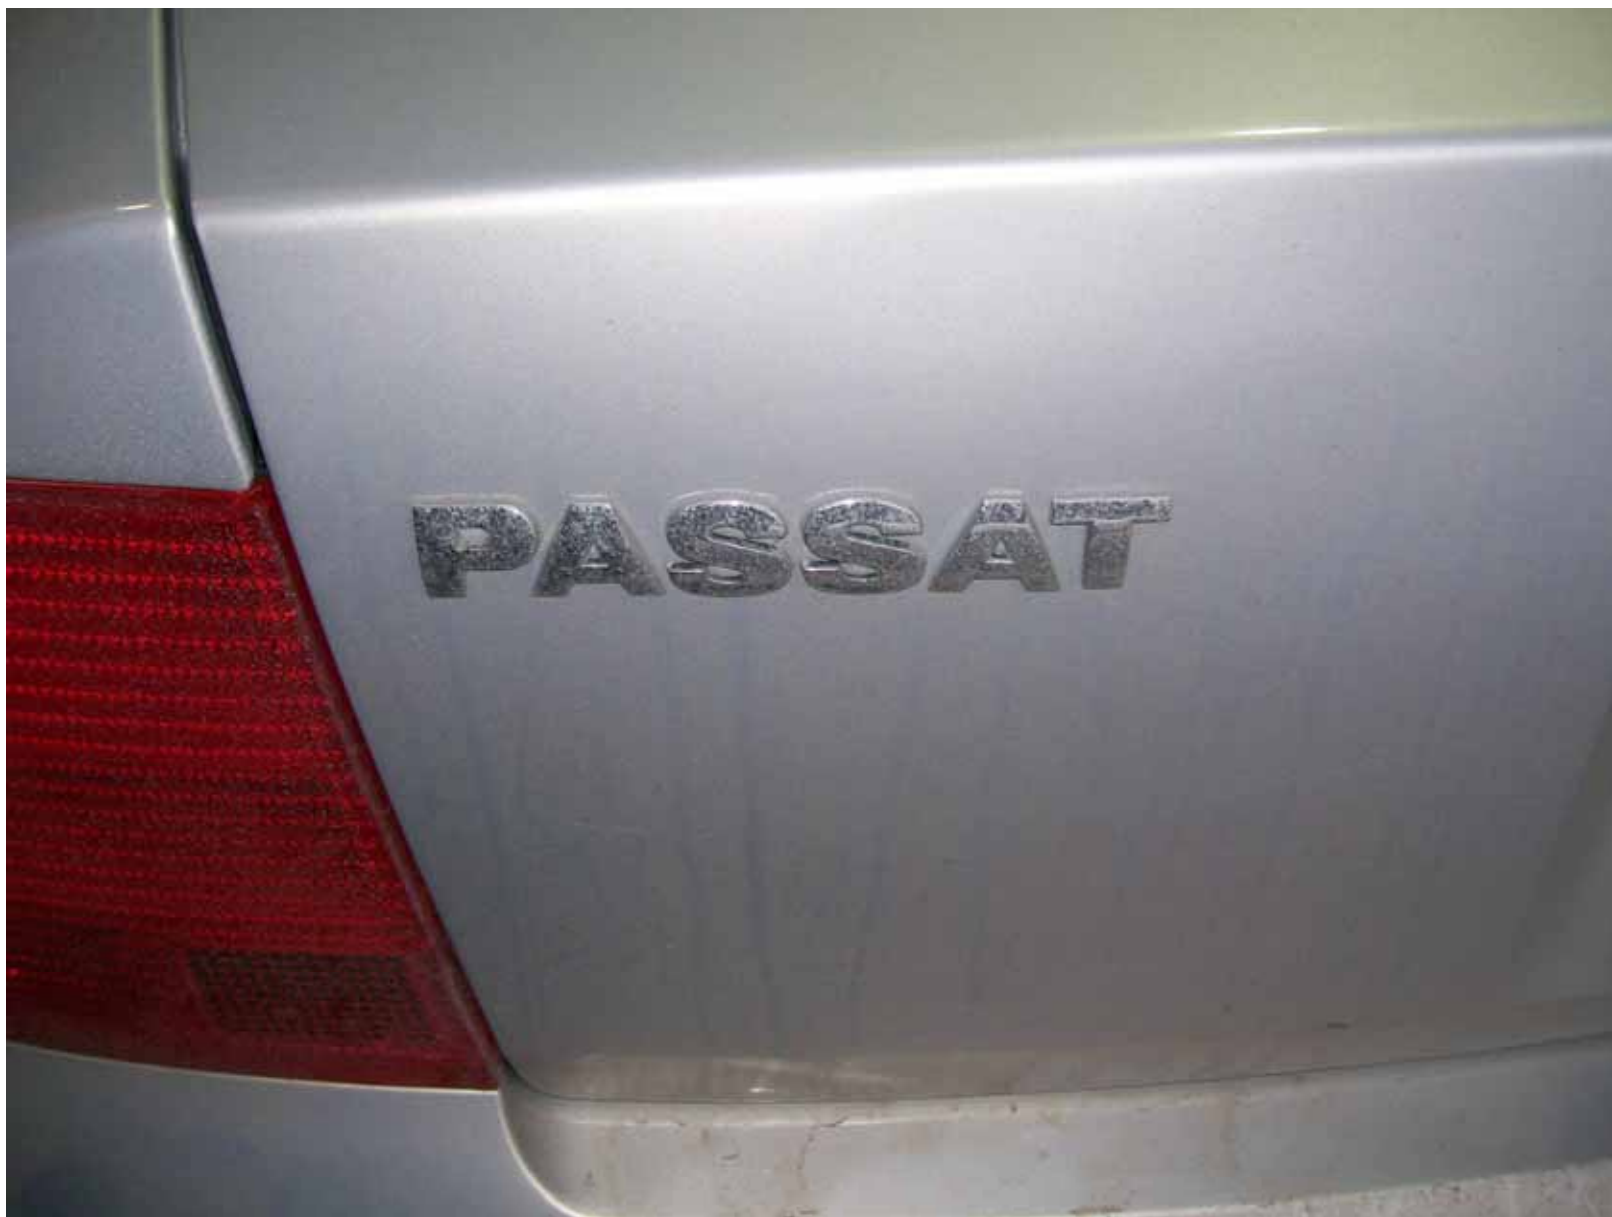
- The pre oxygen sensor went low and the post went slightly high.
- There is now misfire activity that is present
- Our vehicle went into what is called *open loop fault* status as a result of the misfire activity

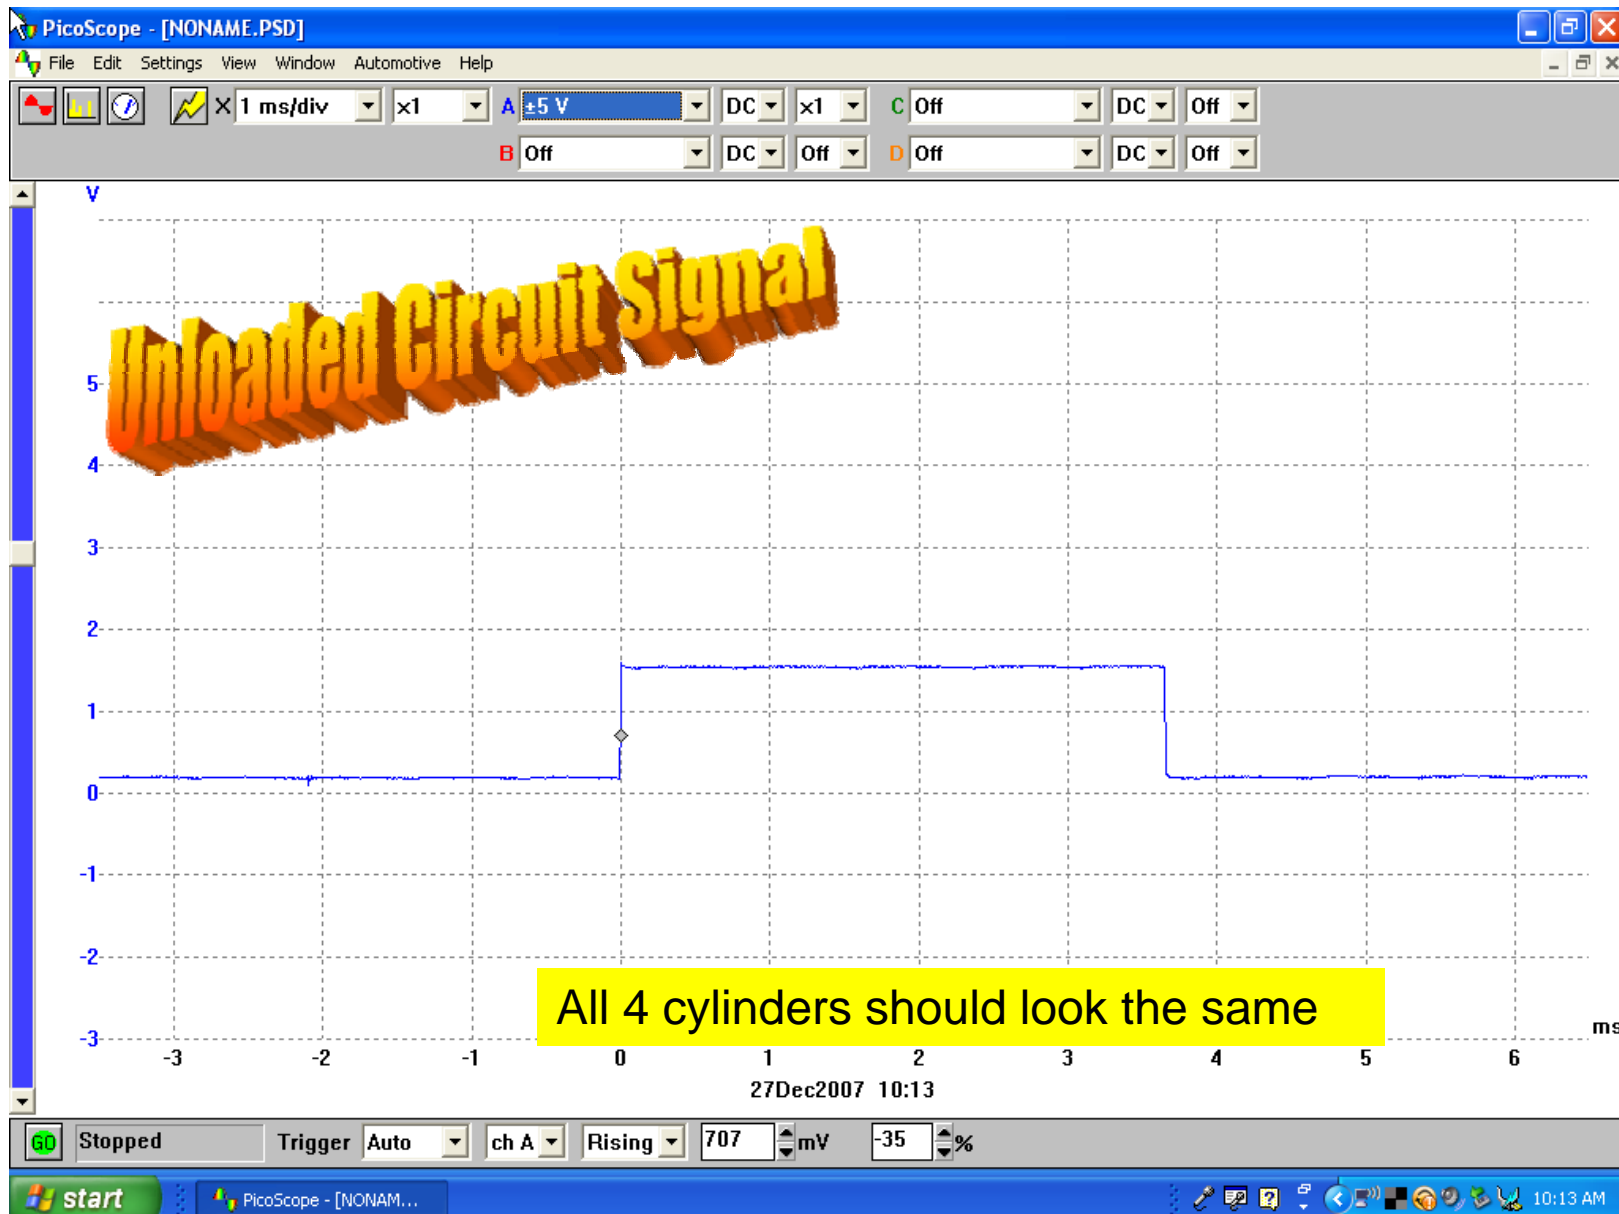
Check the unloaded circuit ignition signals integrity from the PCM using a labscope

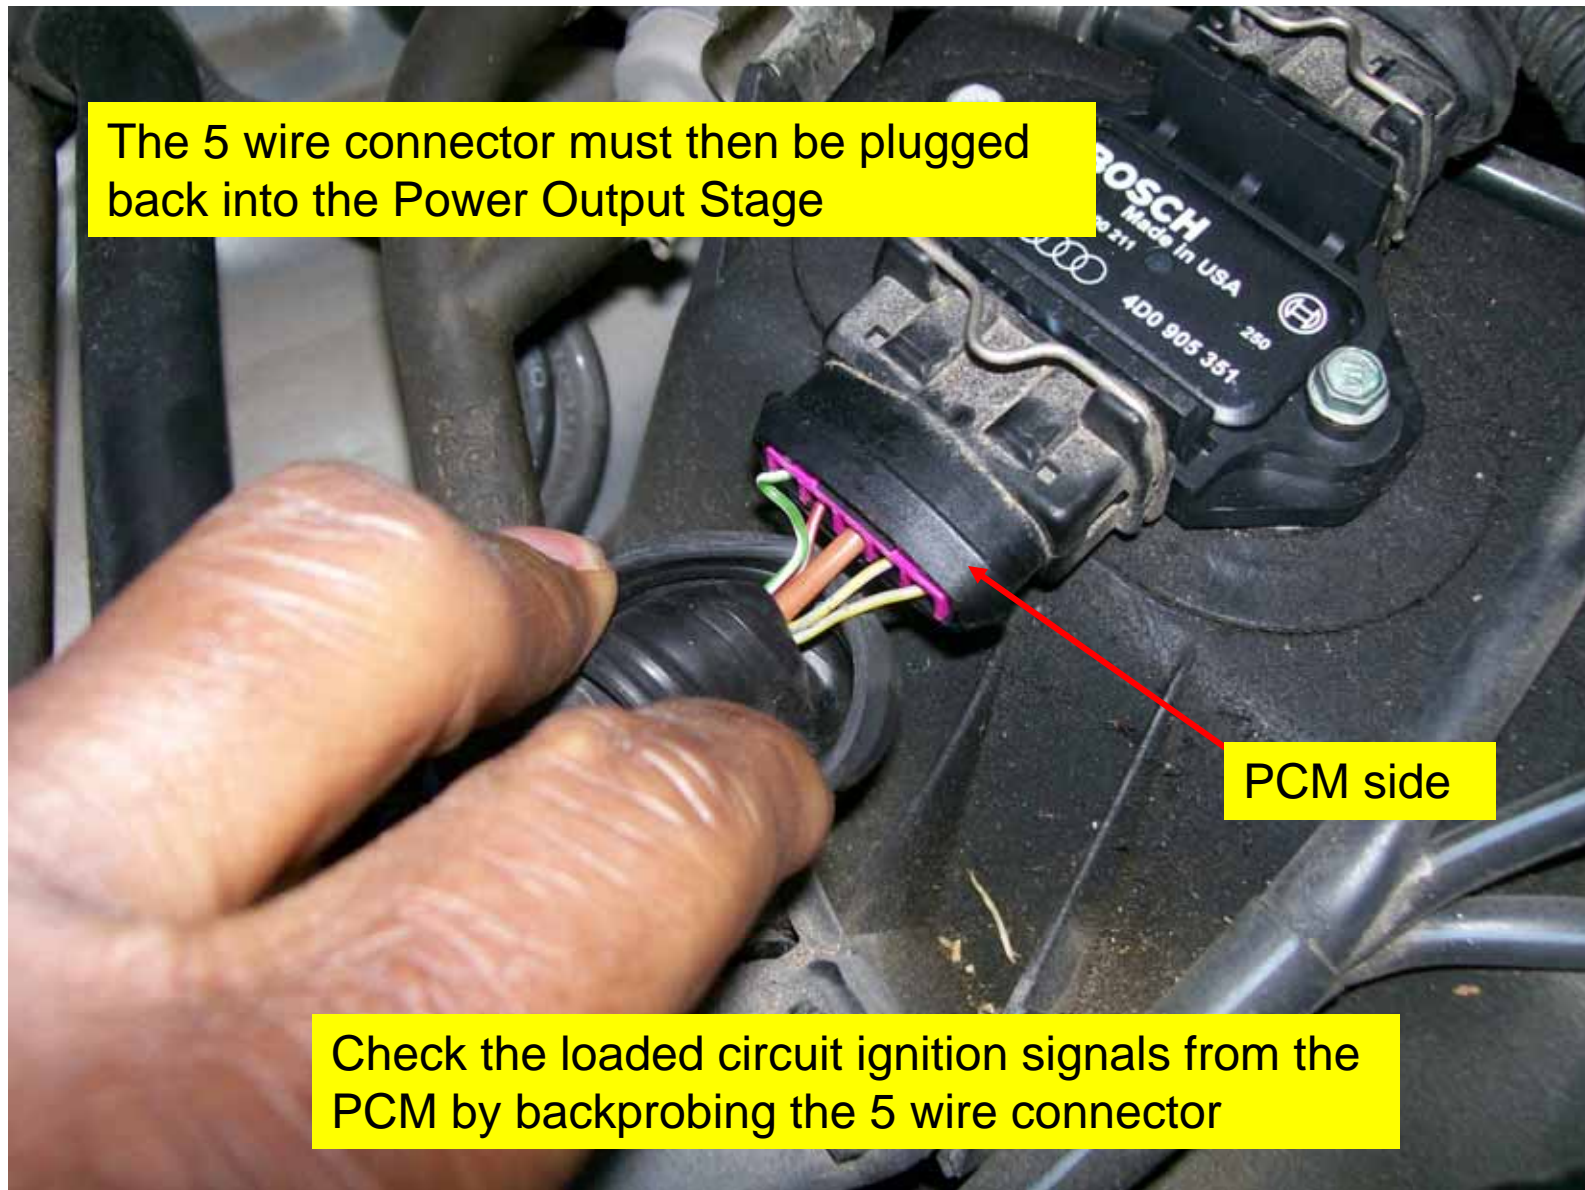
The 5 wire connector must then be plugged back into the Power Output Stage

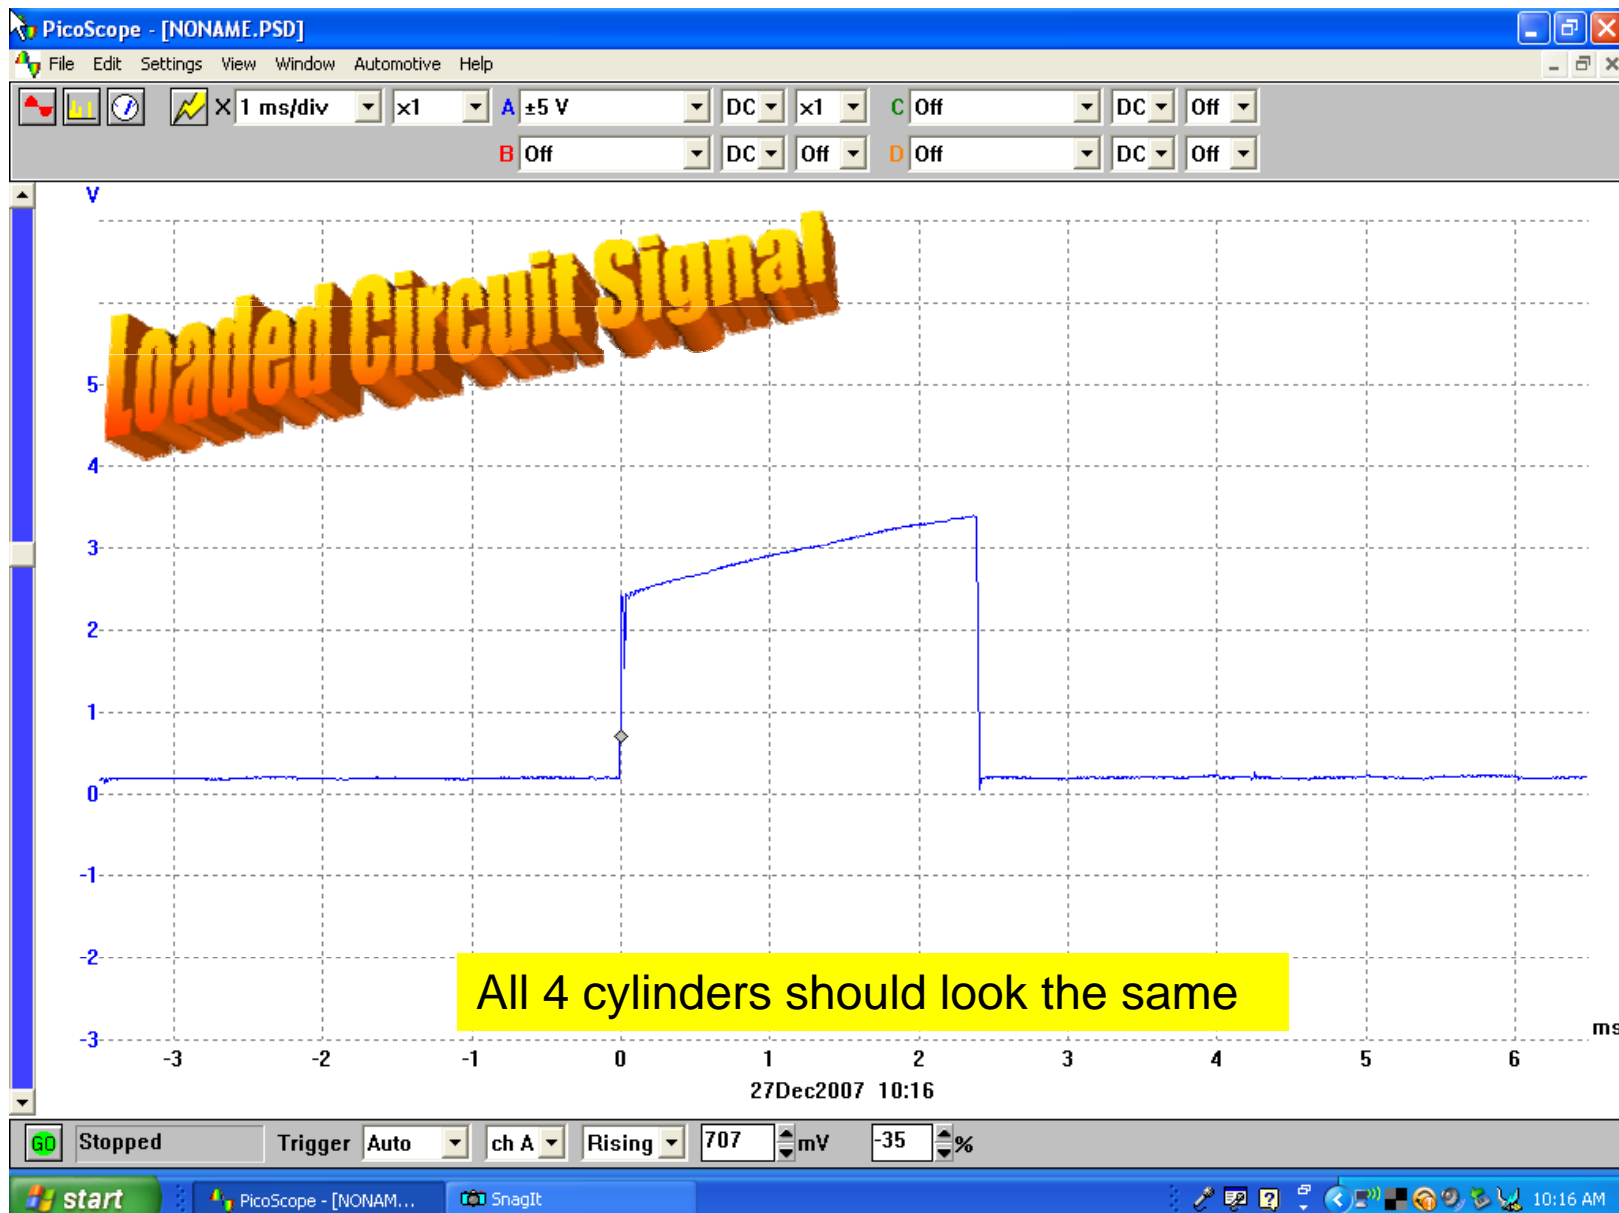
Check the loaded circuit ignition signals from the PCM by backprobing the 5 wire connector

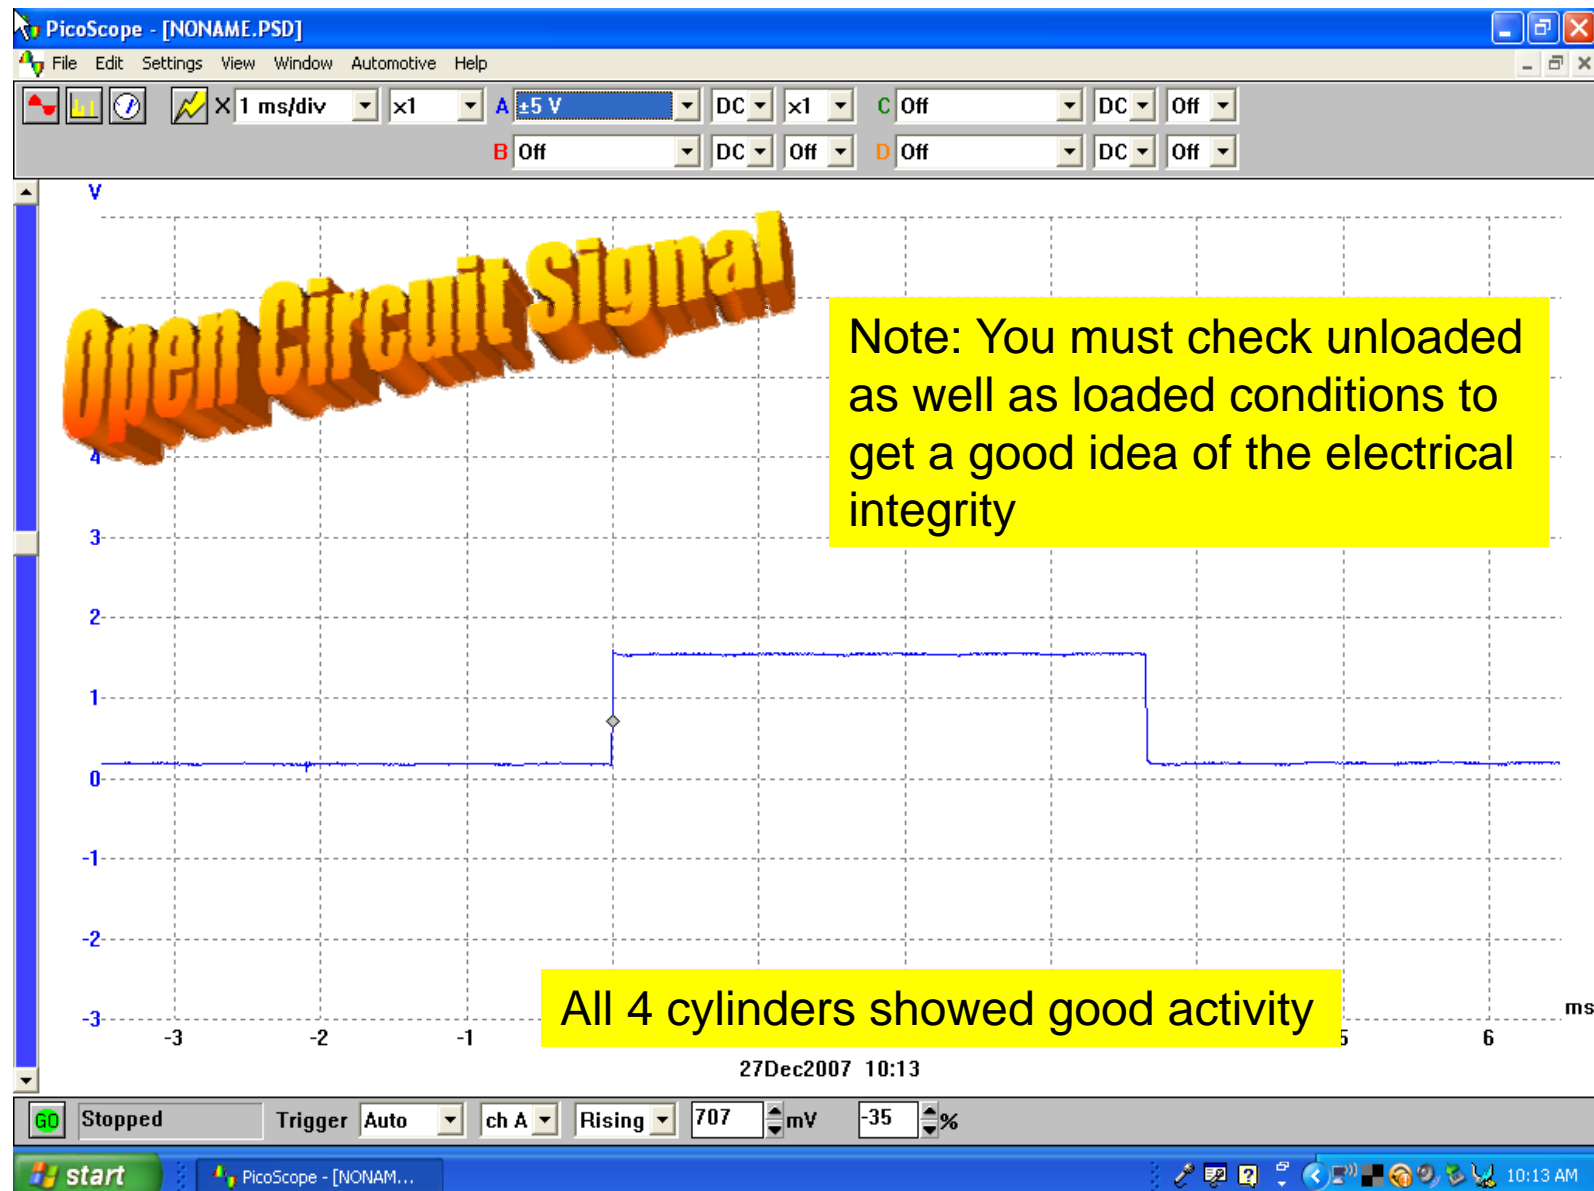
- Cylinders 1,2,3 and 4 showed good open circuit PCM ignition trigger patterns
