## 166 rear side door descending window glass guide (one) - r r with door panel (and support frame) removed 7010D22

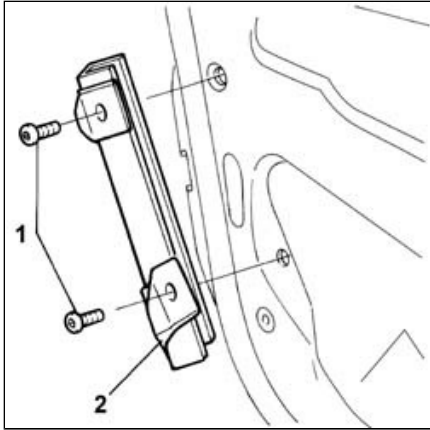
1. With the window fully raised, unscrew the bolts retaining the guide to the door.
2. Remove the guide.

Check the condition of the guide.

Fit the guide.

Tighten the retaining bolts.
