REPAIR KITS

I004

Full Repair Kit: 68459241AA

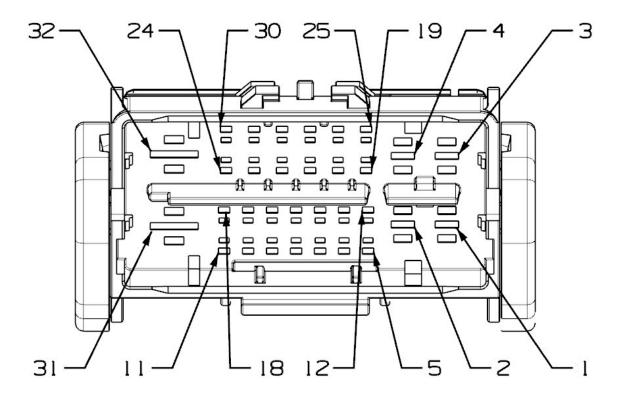
End View

Cav	Circuit	Gauge	Color	Function
1	A901	2.5	PK	FUSED B(+)
2	Z331	2.5	WH	GROUND
3	P188	1	BK	PASSENGER FRONT SEAT HEATER CONTROL
5	A214	0.5	RD/GN	FUSED B(+)
6	Z341	0.5	WH/DB	GROUND
13	D158	0.35	BU/BK	CAN IHS (-)
14	D157	0.35	PK/DB	CAN IHS (+)
15	R57	0.5	GN	DRIVER SEAT BELT BUCKLE SWITCH SENSE
16	R730	0.5	WH	PASSENGER SEAT DETECTION RETURN
20	R730	0.35	OG	PASSENGER SEAT DETECTION RETURN
21	R263	0.35	PK/BK	DRIVER SEAT POSITION SENSOR VOLTAGE
22	R7	0.5	GN/YE	LEFT SEAT THORAX SQUIB 1 LINE 1
23	R5	0.5	OG/BK	LEFT SEAT THORAX SQUIB 1 LINE 2
24	Z331	0.5	BK	GROUND
25	P968	0.5	YE/DB	HEATED SEAT SENSOR RETURN
26	P688	0.5	GY/RD	PASSENGER FRONT HEATED SEAT TEMP SENSE
27	C91	1	GY	HEATED STEERING WHEEL FEED
28	A214	0.5	BU/RD	FUSED B(+)
